HISTORIC STRUCTURE REPORT

Lear Theater

City of Reno | October 18, 2024

Lear Theater Structural Condition Assessment

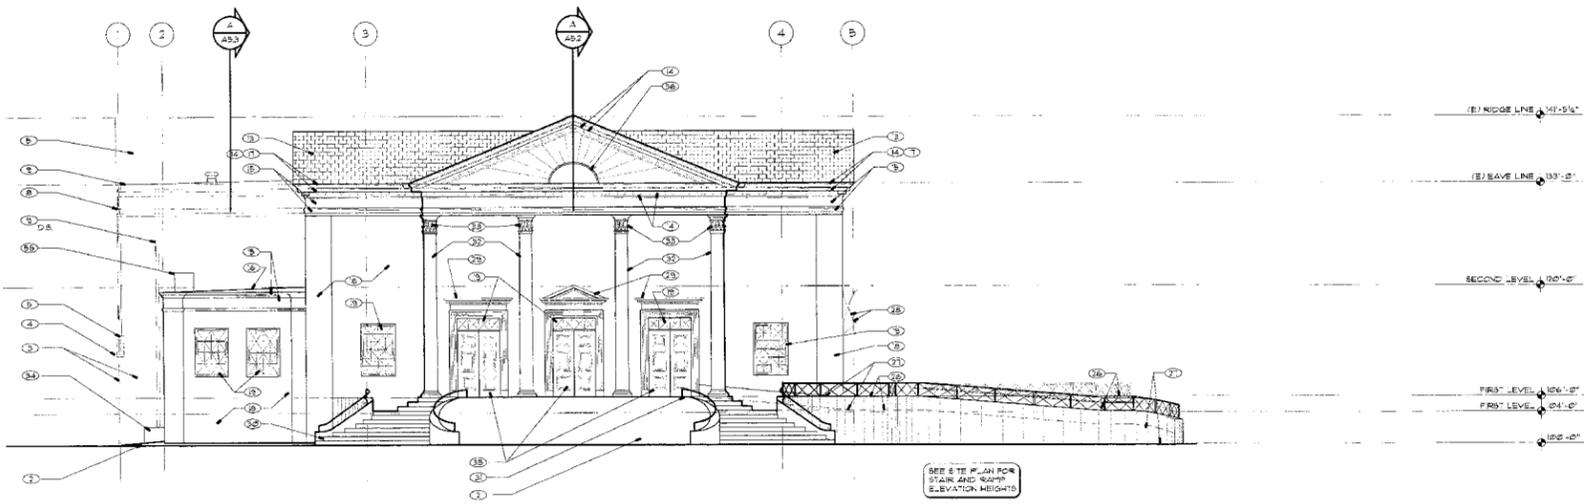
south elevation

4 | ITEM M24
THE SOUTH AND EAST ELEVATIONS ALONG WITH EXISTING NORTH AND WEST PORTIONS TO REMAIN HAVE CONSIDERABLE STUCCO CRACKS. A 1/2" PLASTER SOFT COAT SHALL BE APPLIED TO THESE ELEVATIONS WITH INTEGRAL COLOR. ALSO THE VERTICAL SURFACES AND TOPS OF NEW RAMPS SHALL RECEIVE THE SAME PLASTER SOFT COAT.

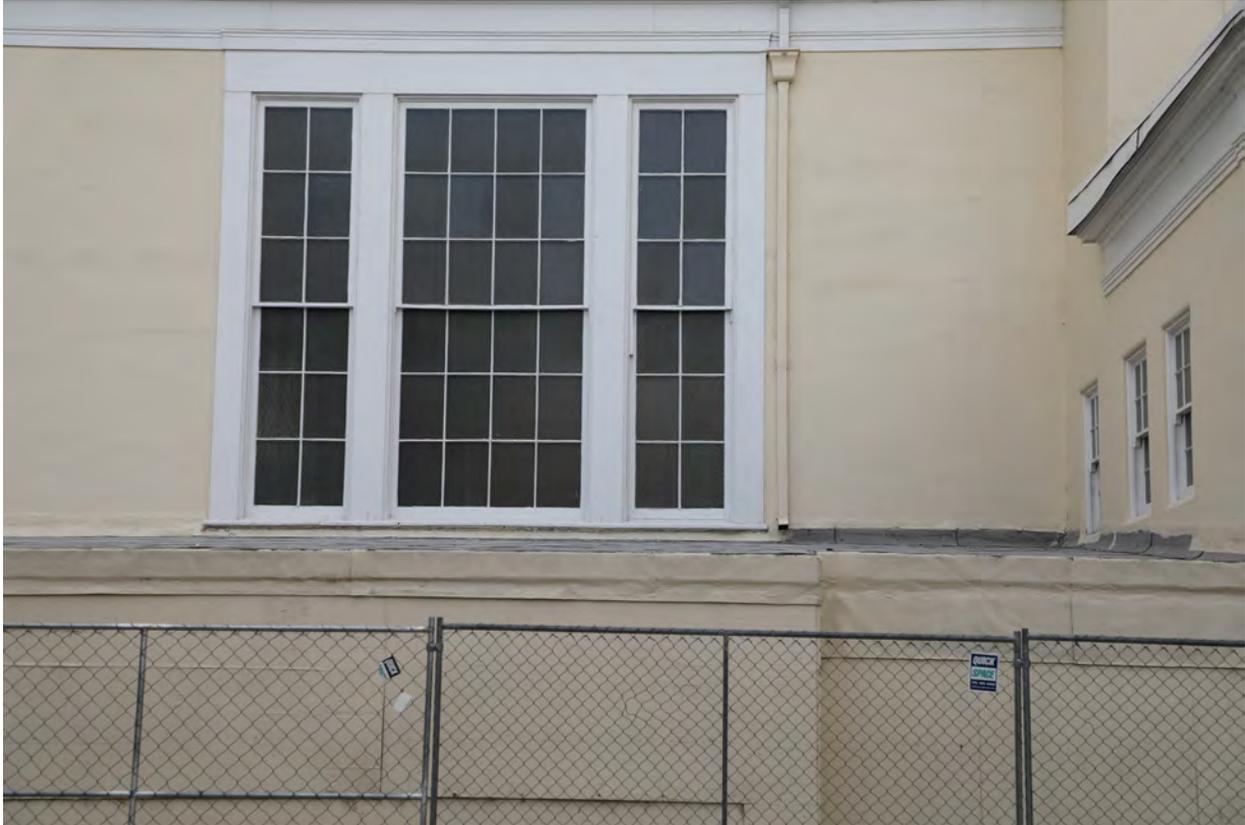
Figure 14 - West facade, looking at large window above temporary structure enclosing incomplete 2002 addition (ARG, 2024)

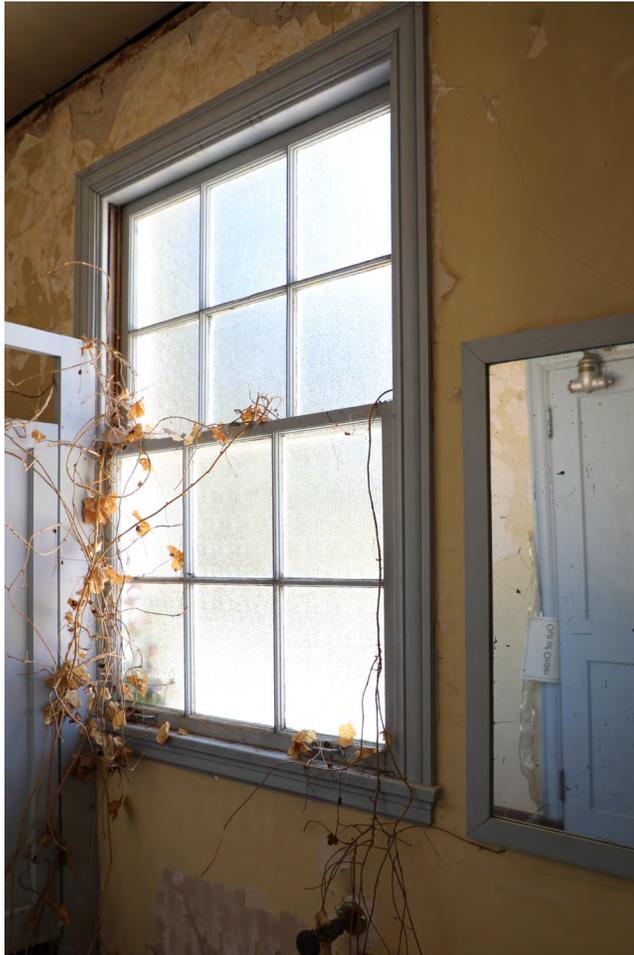
Figure 26 - Looking at plant growth through window in west restroom, view southwest (ARG 2024)

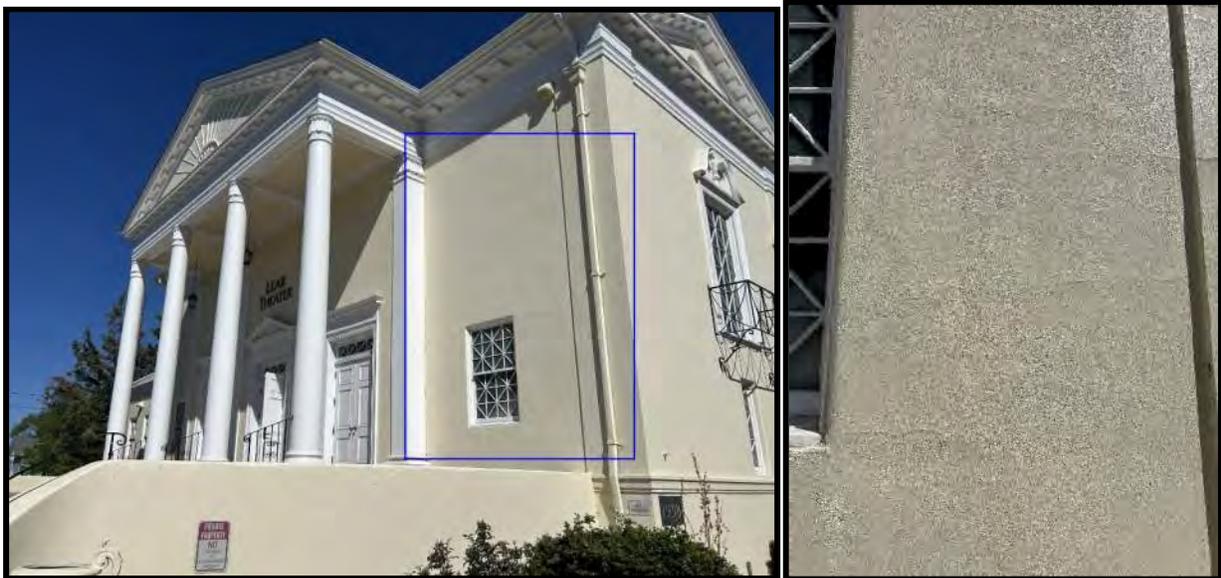
Overall, the interior and exterior wall framing appears to be in good condition. A few hairline cracks were observed in the south entrance wall finish (**Figure 25**), and in the southern room finishes (see **Figure 26** and **Figure 27**). Given the size, these cracks are likely only in the wall finishes and are not a significant structural concern.

Figure 25 View of cracking in the exterior wall finishes from further away (left) and close up (right) at the south theater entrance.

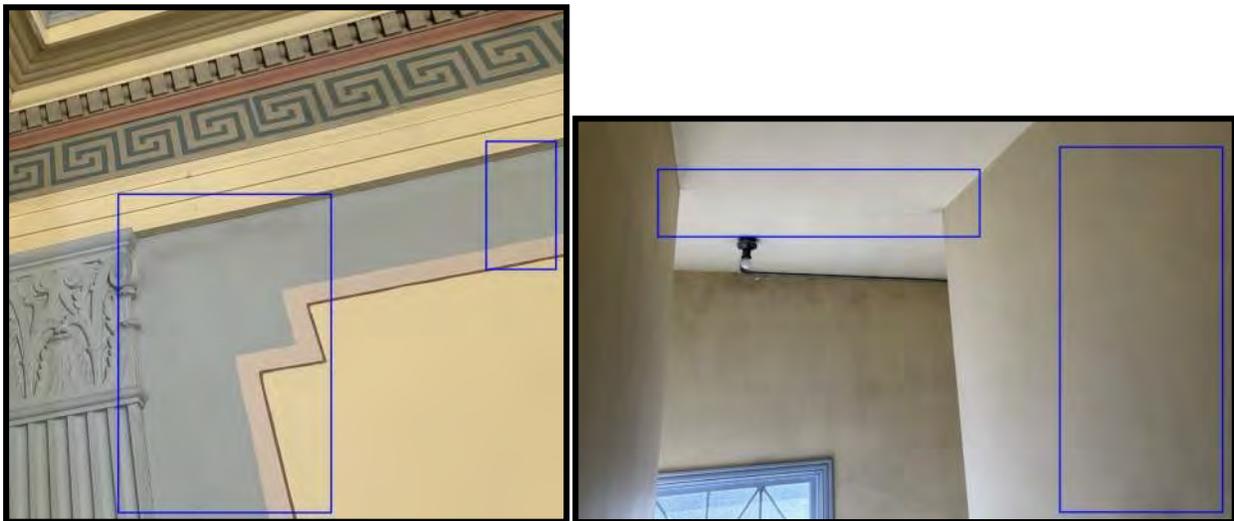
Figure 27 View of hairline cracks in the second-floor rooms and stairways highlighted in the previous figure.

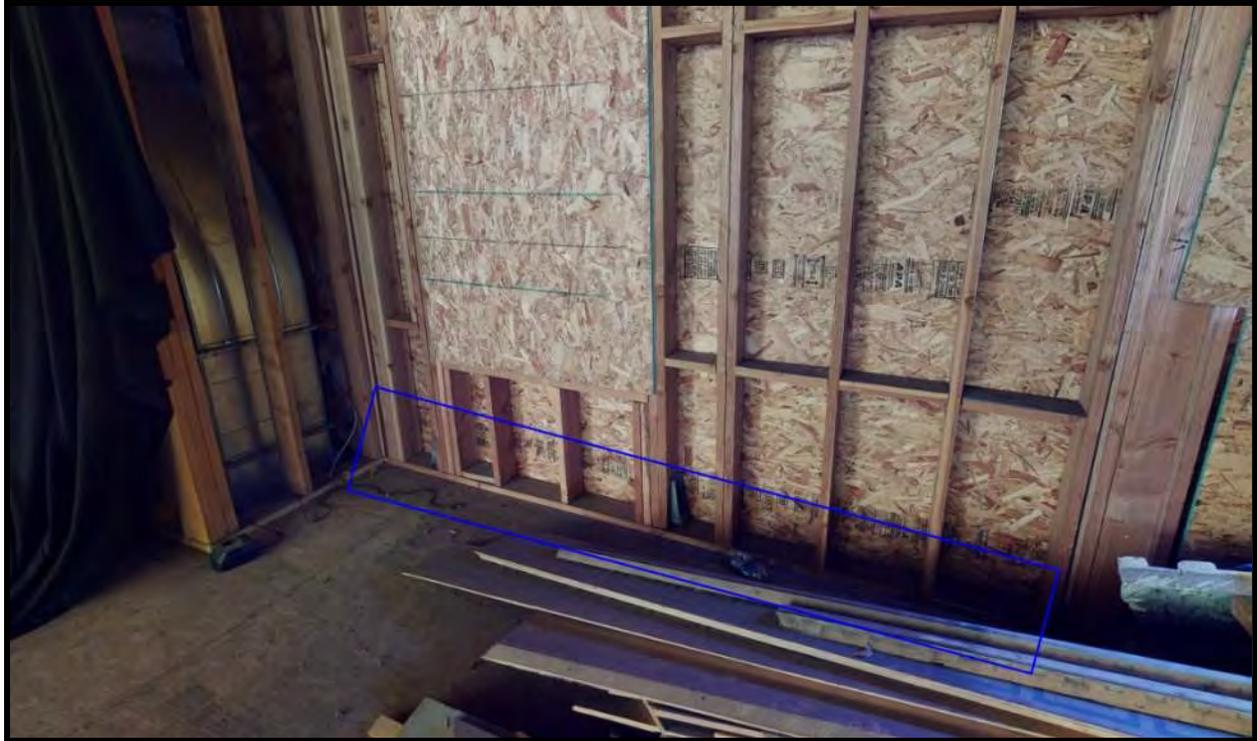
In addition to the minor cracking observed, Silman also noted that the shear walls all appear to be missing sill anchor bolts (see **Figure 28**). Should a lateral event occur, the walls would likely not be able to transfer the loads into the foundation, resulting in significant displacement. According to the 2002 Construction Drawings, 5/8" anchor bolts at 32" on-center or 16" on-center should have been installed.

Figure 28 View of missing sill bolts at the north wall of the stage.

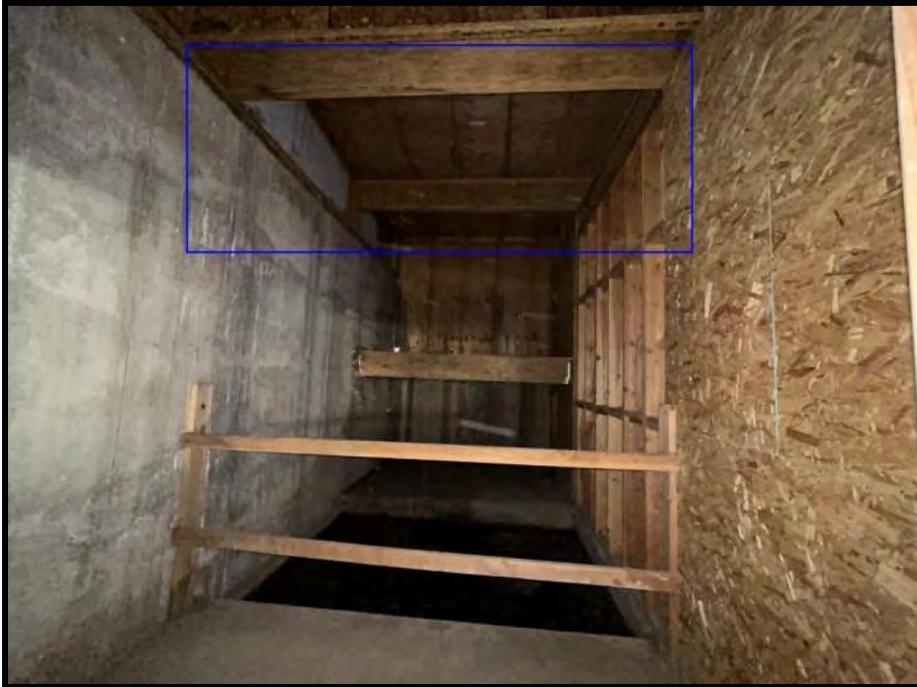
As mentioned in the Structural Description portion of the report, the west wing framing retrofits from 2002 were not completed. Instead, any new construction was mostly completed in the basement, and a sleeper floor was added over the first-floor framing (see **Figure 13**). Where there were openings in the first-floor framing for future elevators or stairs, the light sleeper floor framing is visible (see **Figure 29**). Note that this framing was not intended to be permanent. However, given that most of the floor framing was designed for higher floor loads, structurally the temporary framing is adequate and can continue to be used.

Figure 29 View of the light framing above the elevator pit in the basement.

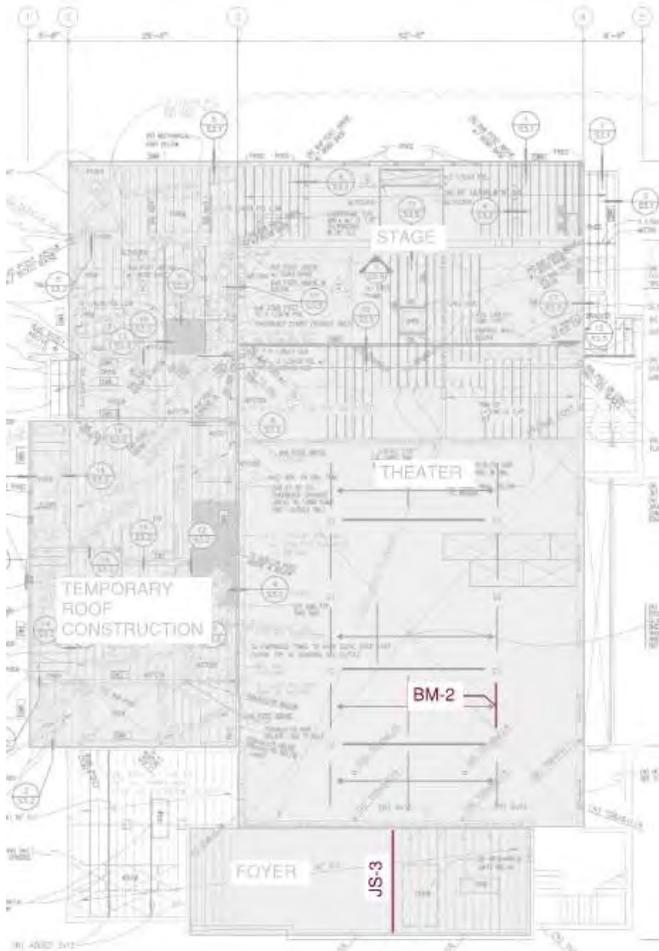
alone was applied. It is therefore likely that the material strength assumptions made for this analysis may not align with the actual properties of the wood material, or that the structure has not actually seen loads as large as those required by current code. Material testing is recommended to refine all analysis results, otherwise some reinforcing may be required to strengthen these members.

Figure 33 First floor plan highlighting the members that do not have sufficient capacity.
