Lear Theater HSR and Concept Design Presentation

Prepared for
City of Reno

Prepared by
Architectural Resources Group

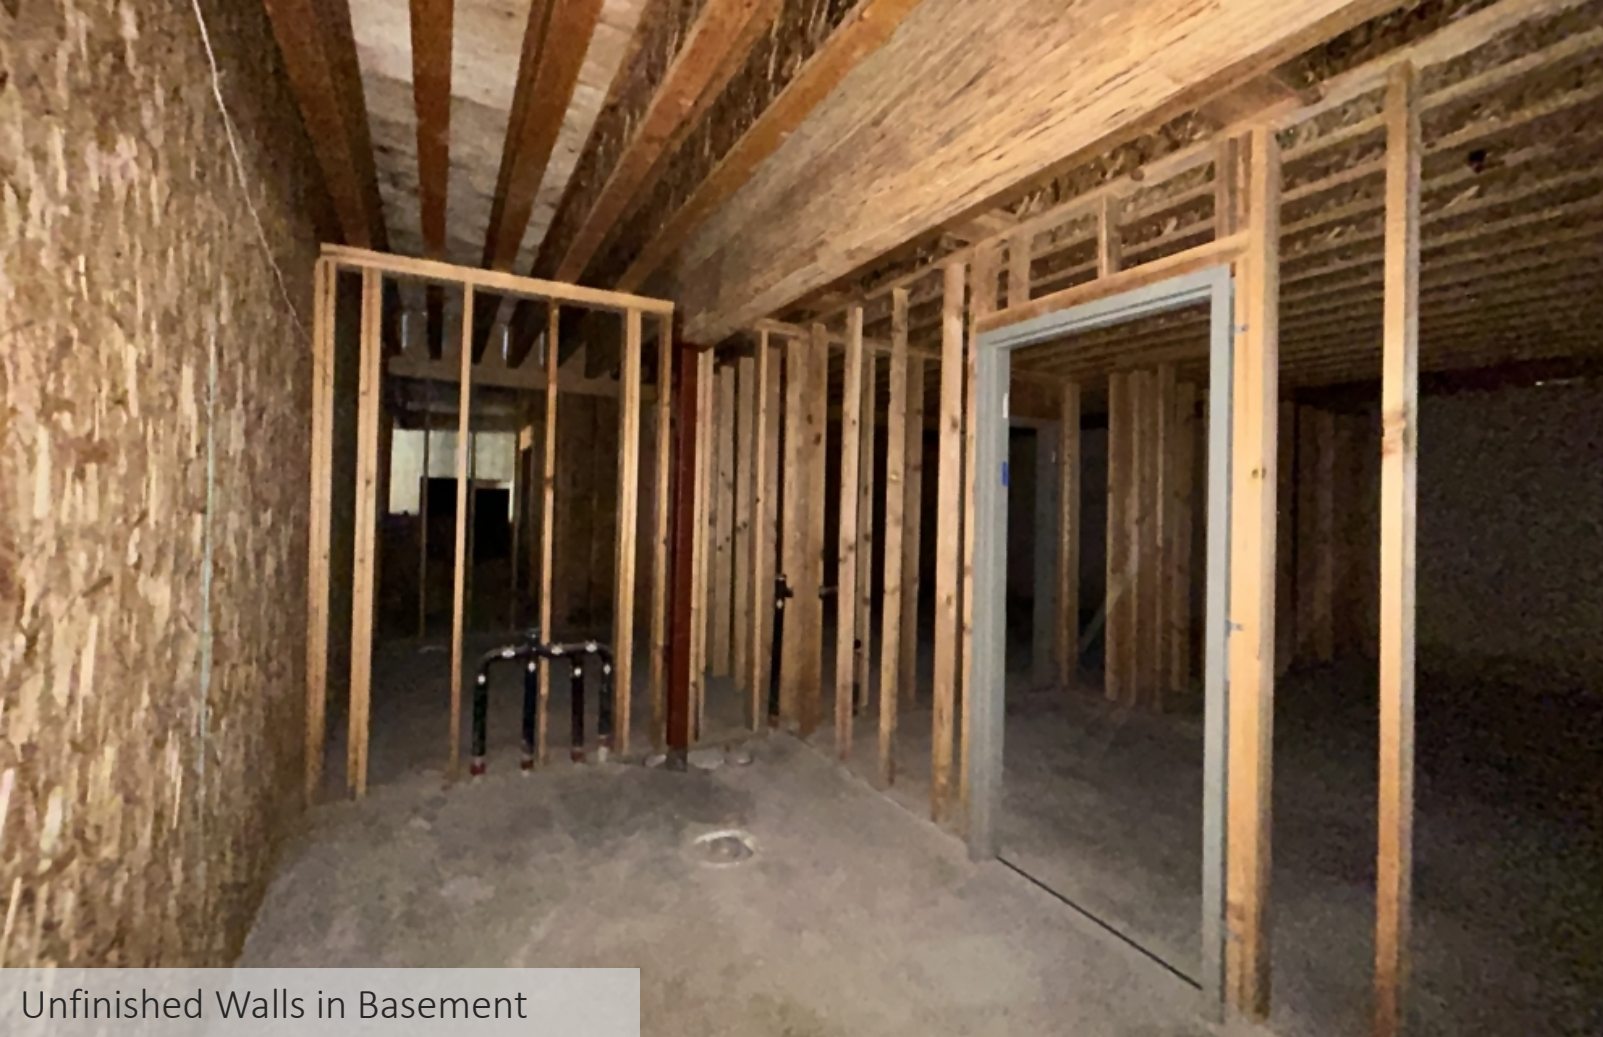
Unfinished Walls in Basement

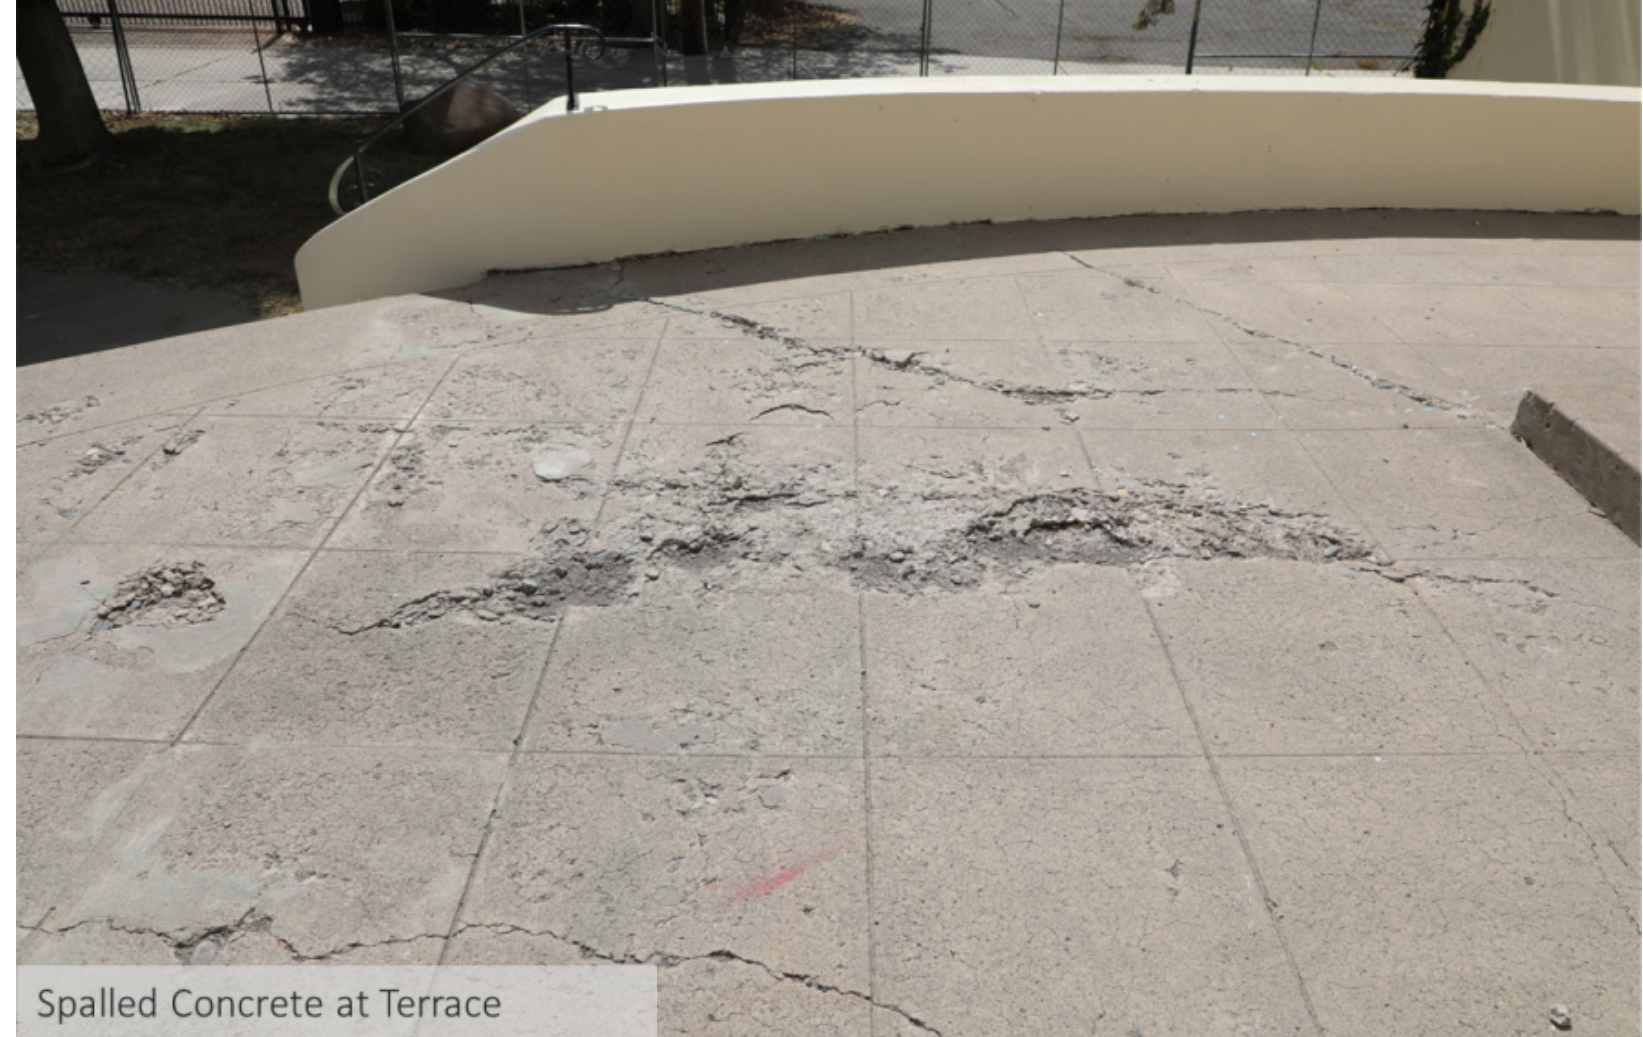
- The concrete slab-on-grade at the Terrace is spalling significantly, otherwise the structure appears to be in good condition.
- The lateral system consists of wood shear walls above the basement. The wood shear walls are missing sill bolts.

Spalled Concrete at Terrace

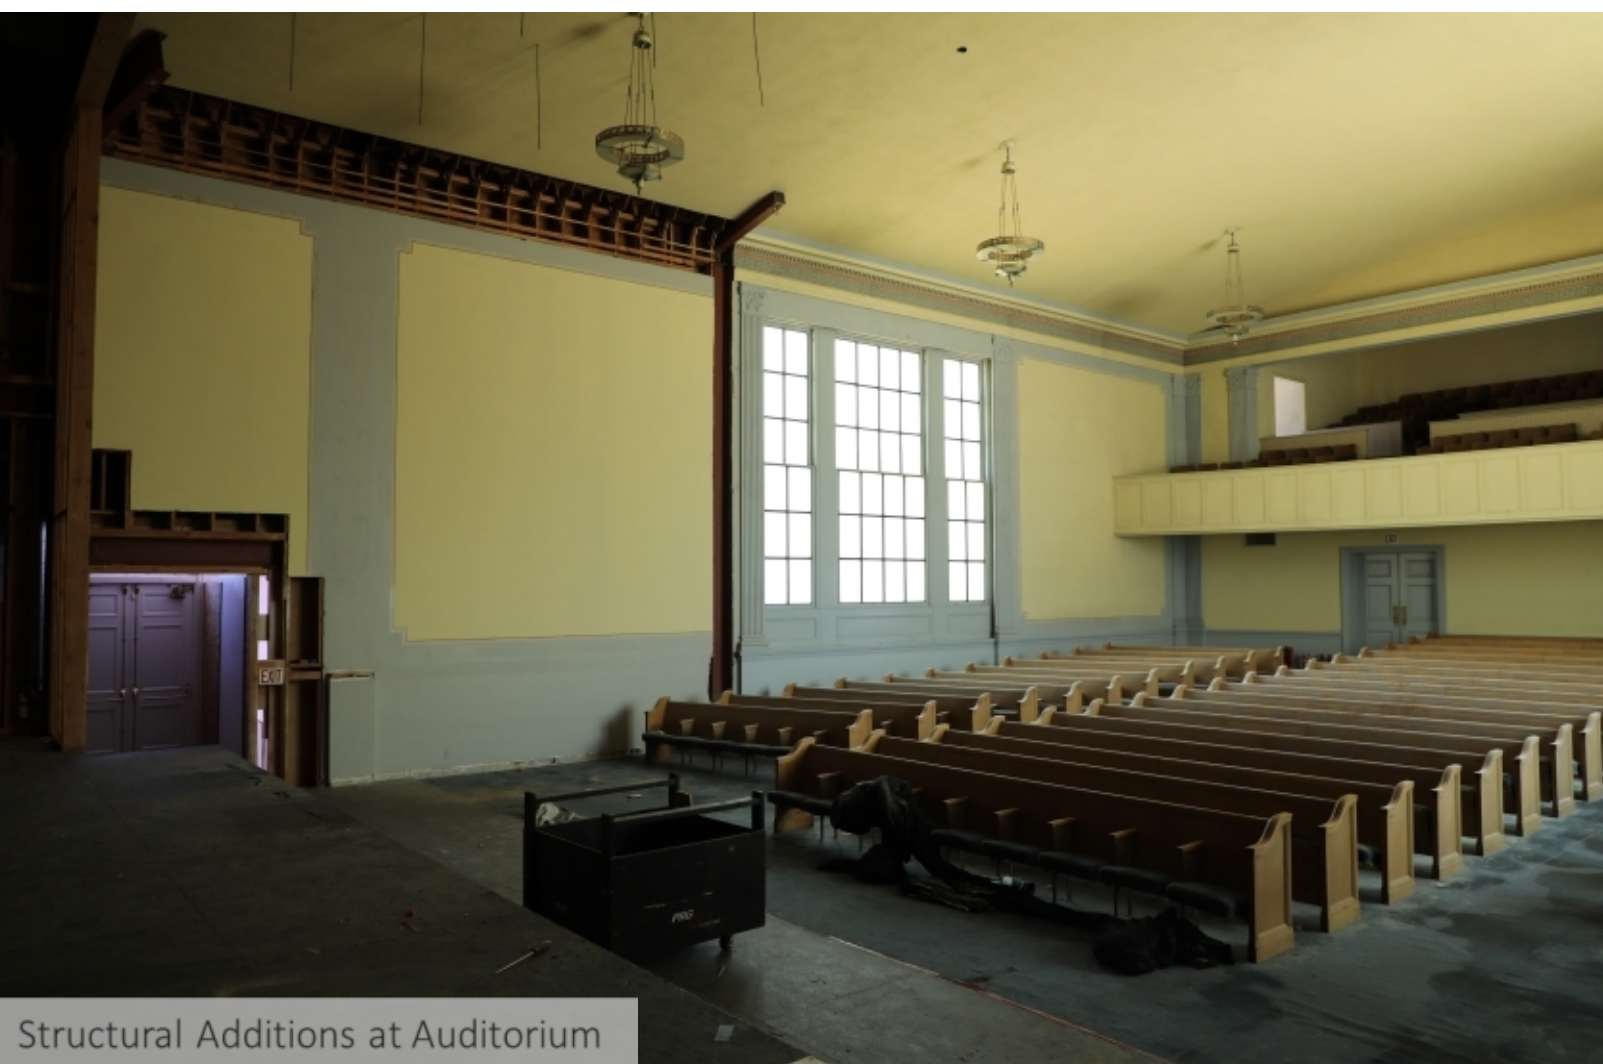
- There is significant steel framing in the auditorium to support the existing roof and stage lighting.
- The roof appears to primarily be in good condition with newer asphalt shingles. However, at the west side of the building, the rolled roofing over the women’s restroom and literature room is in poor condition.

Structural Additions at Auditorium

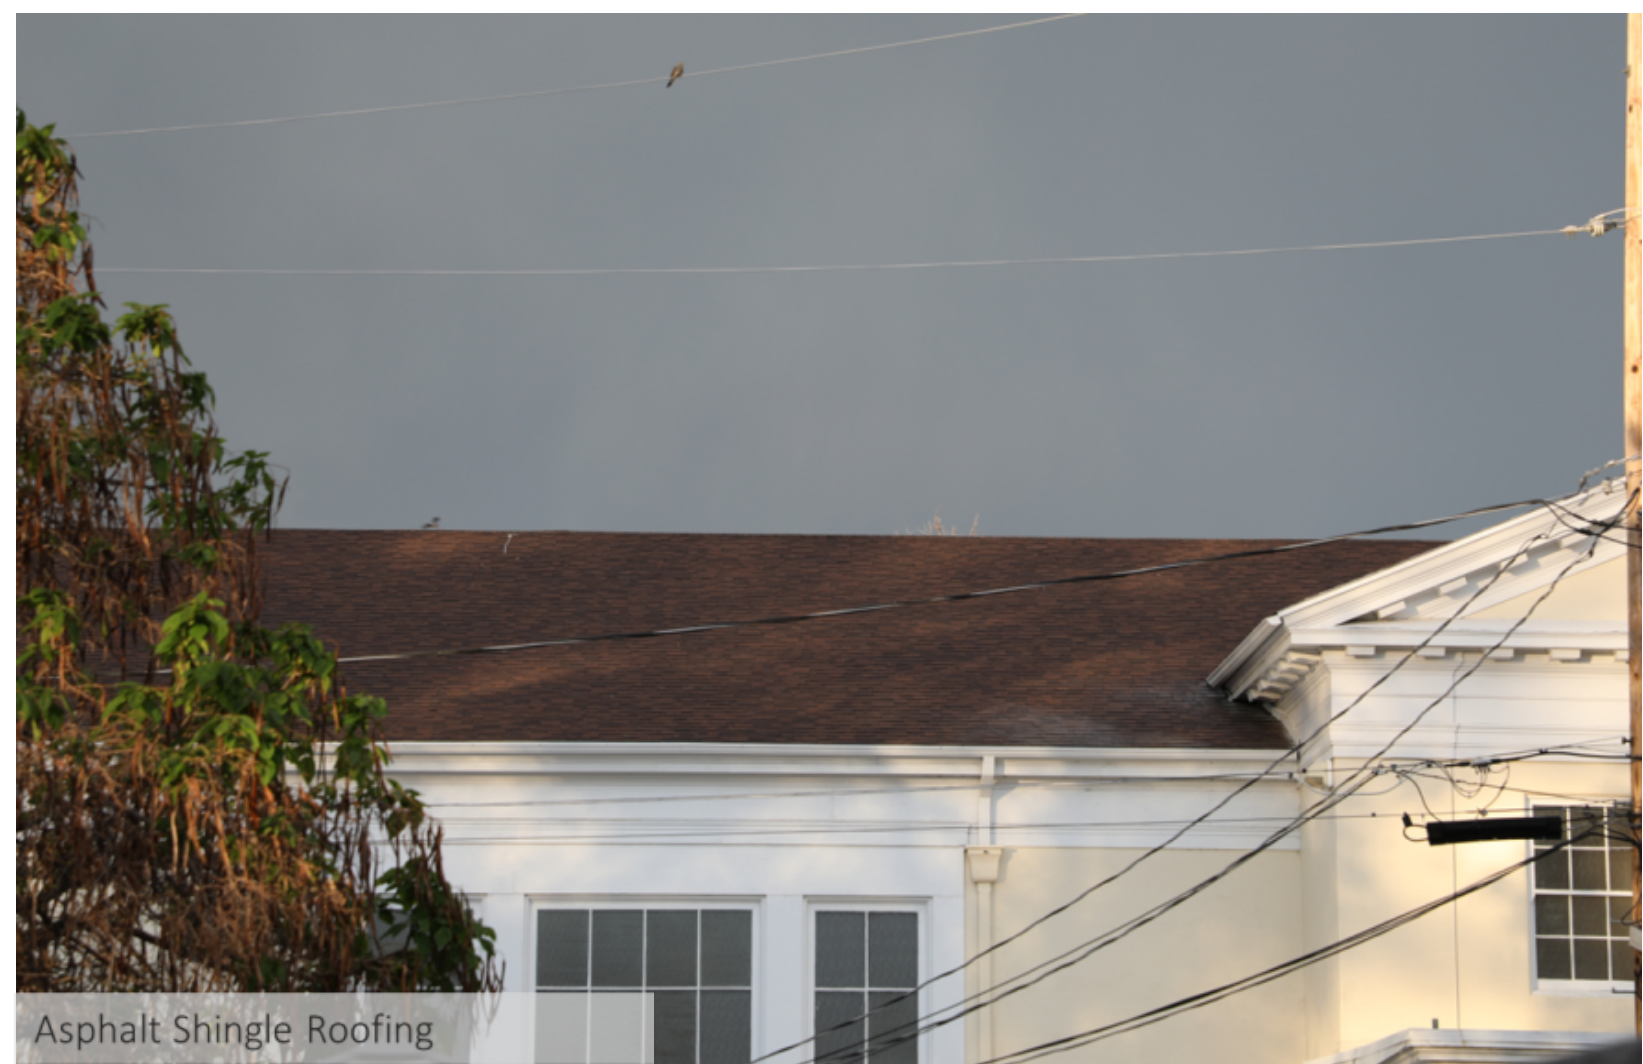
Asphalt Shingle Roofing

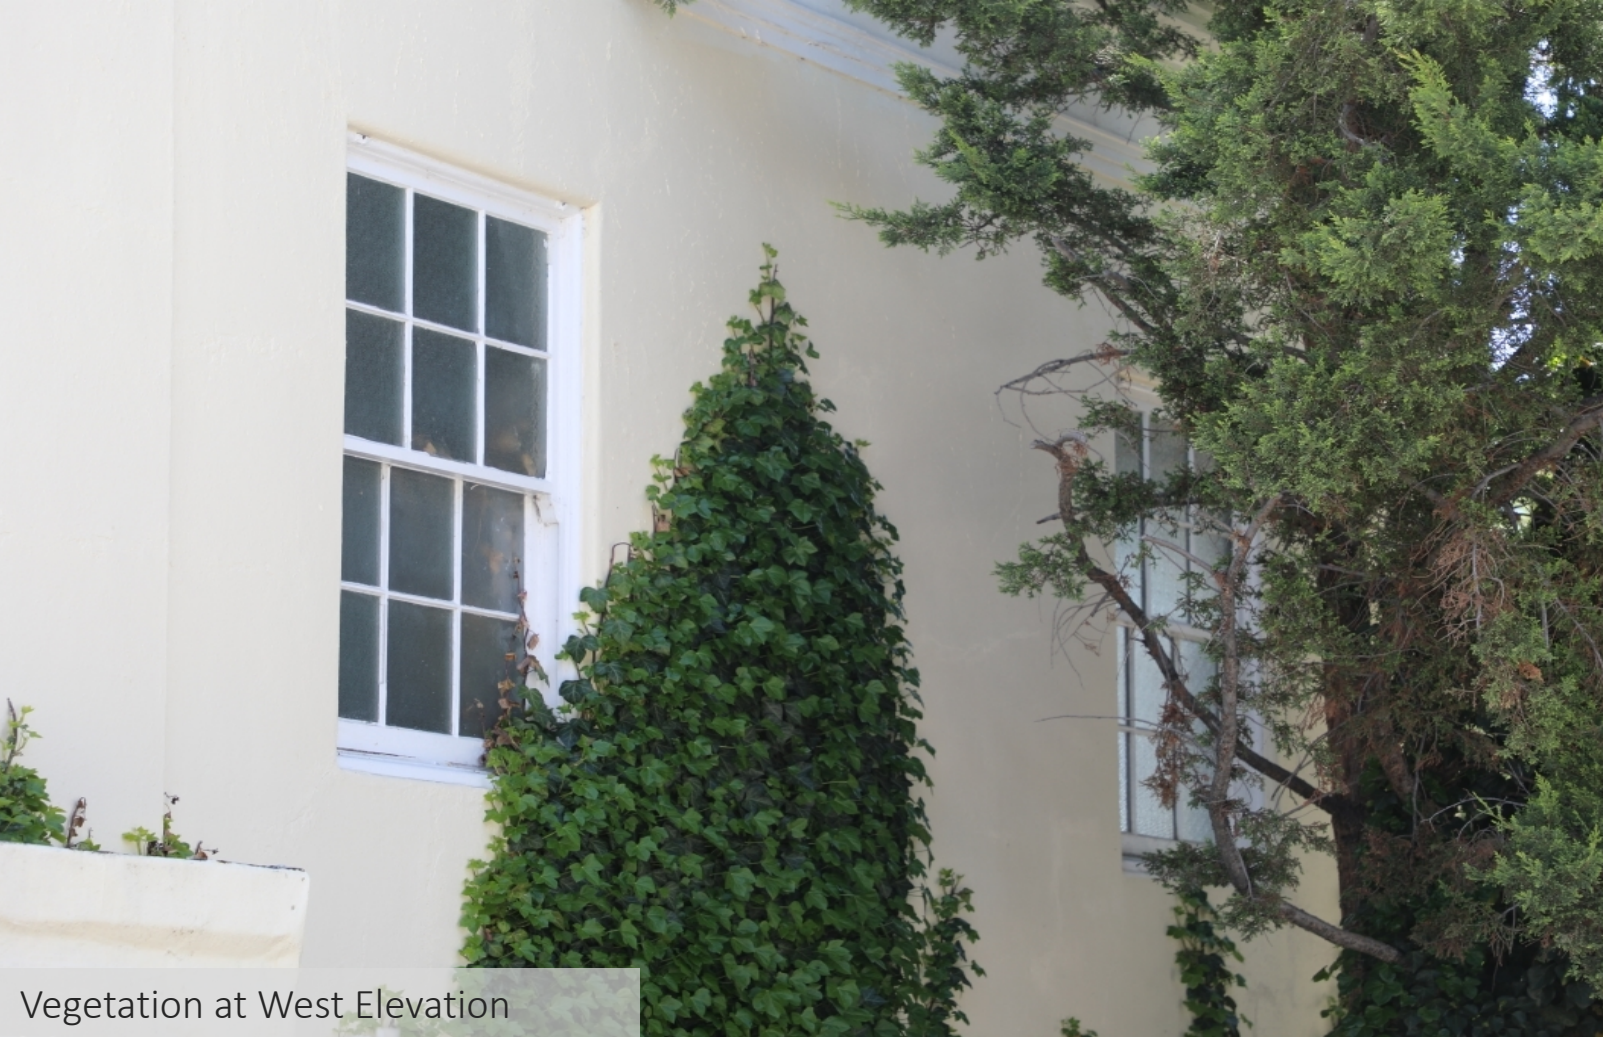
Vegetation at West Elevation

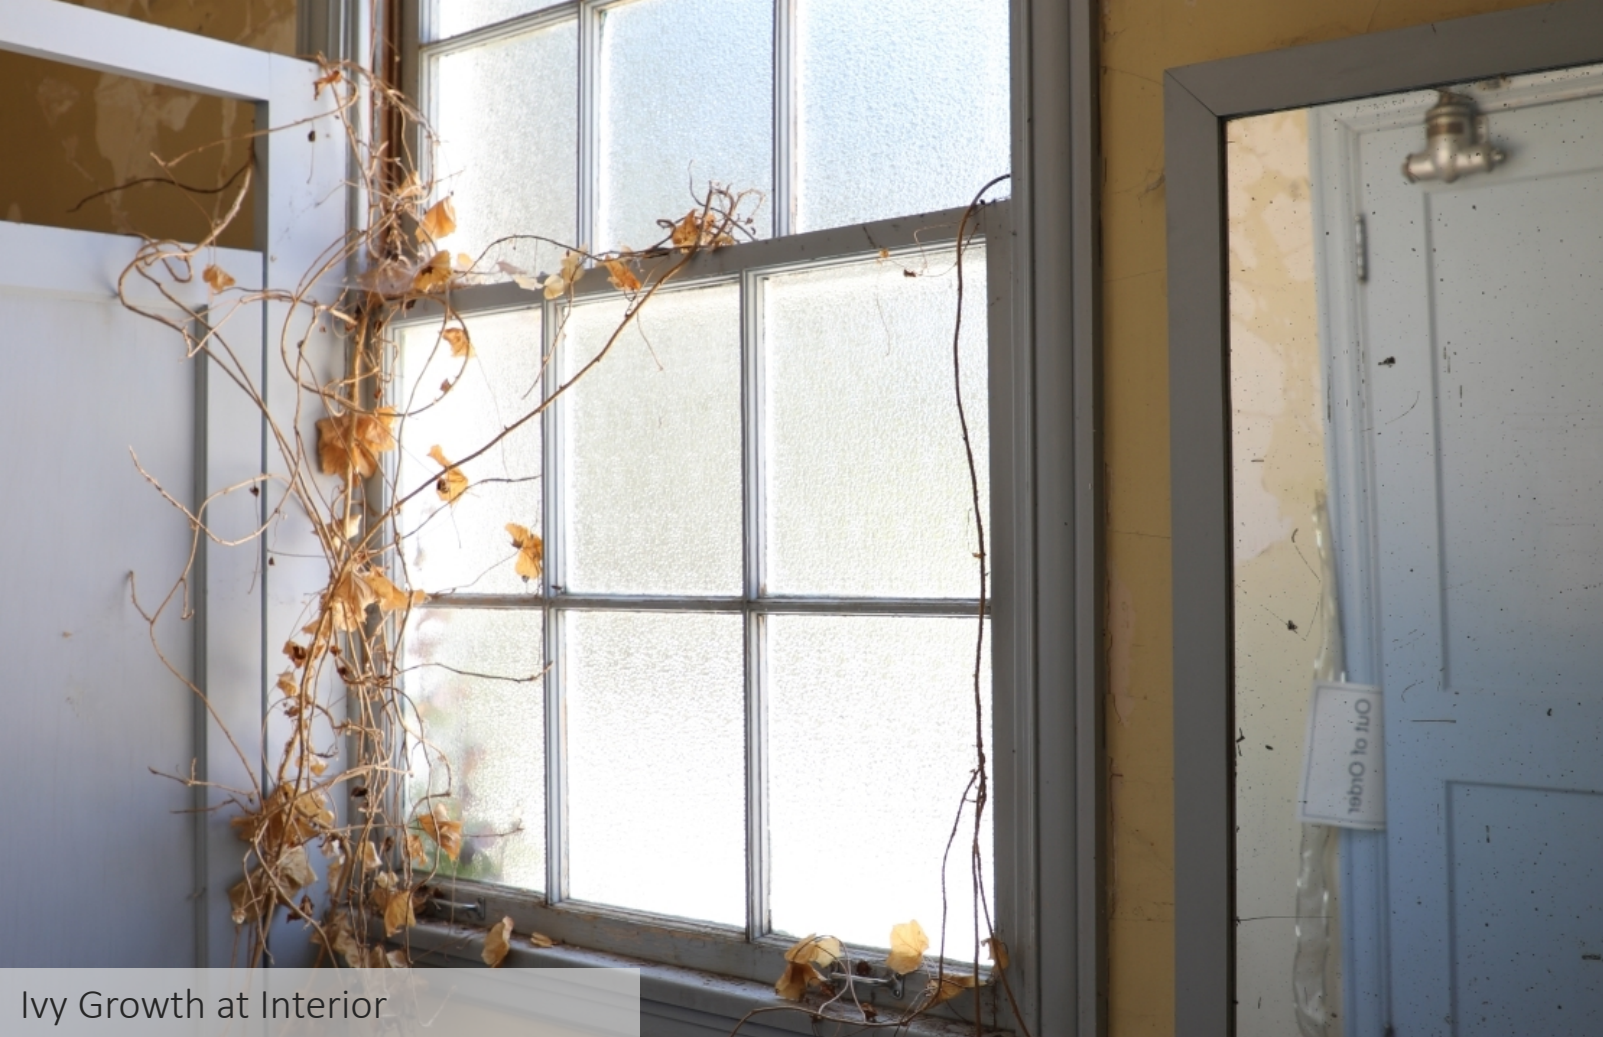
Ivy Growth at Interior

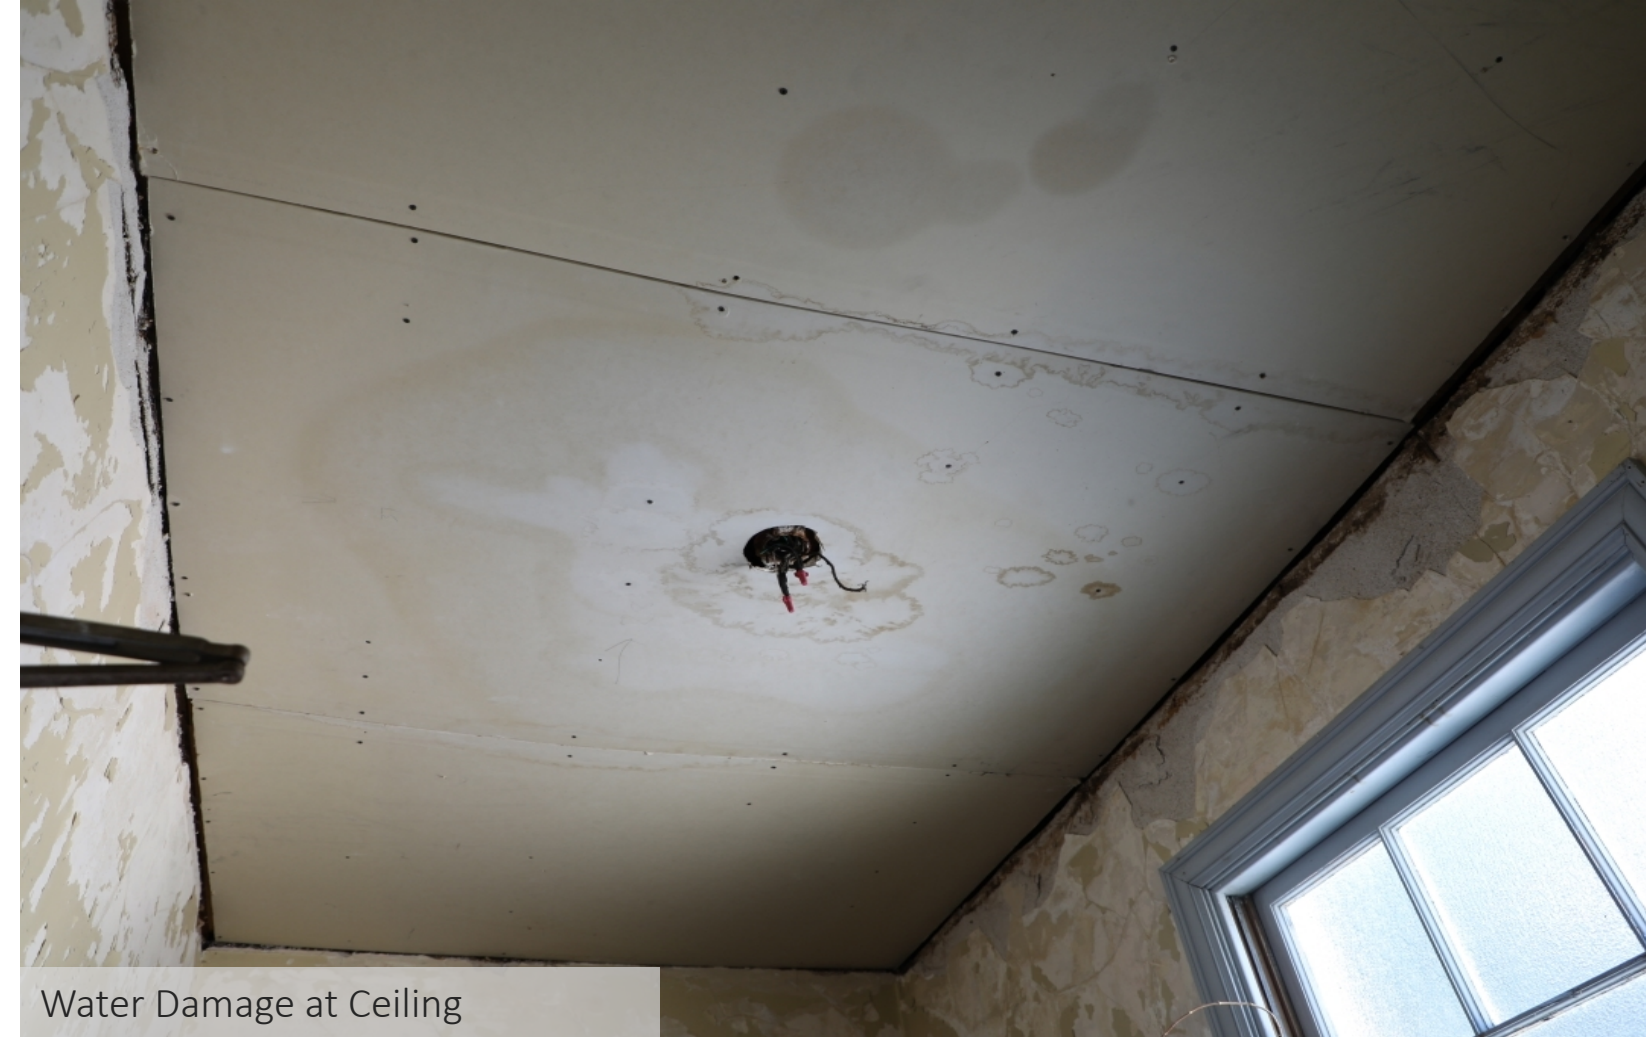
Water Damage at Ceiling

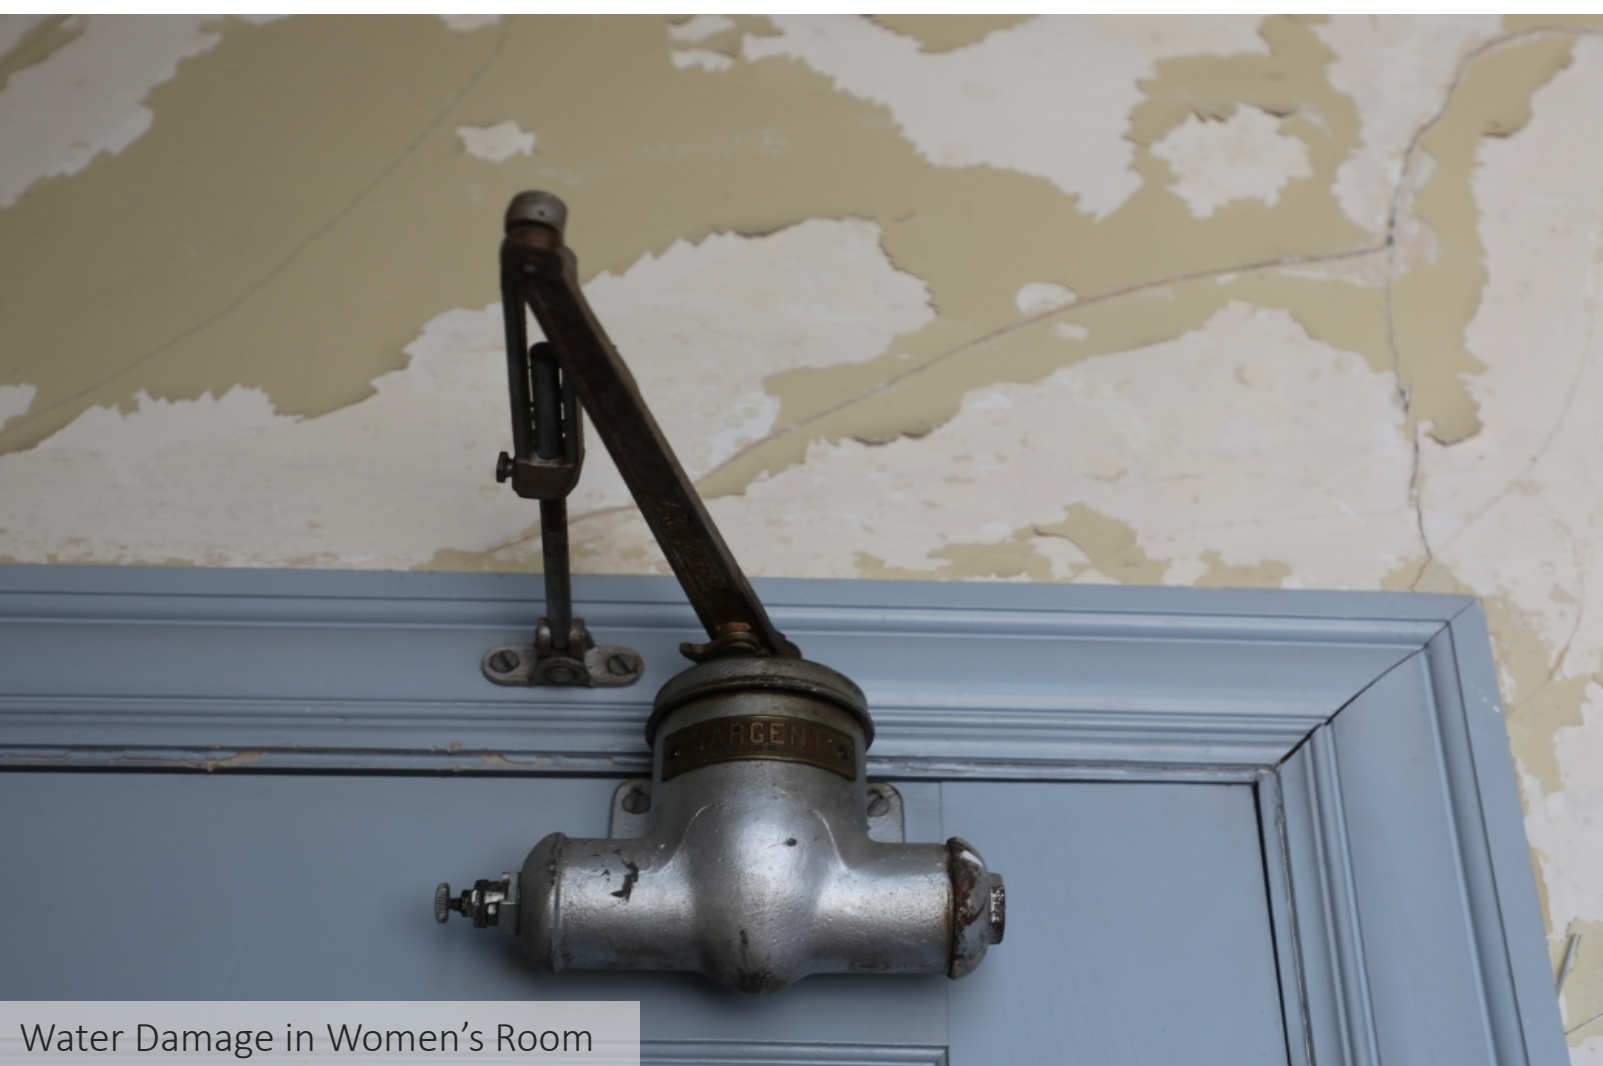
Water Damage in Women's Room

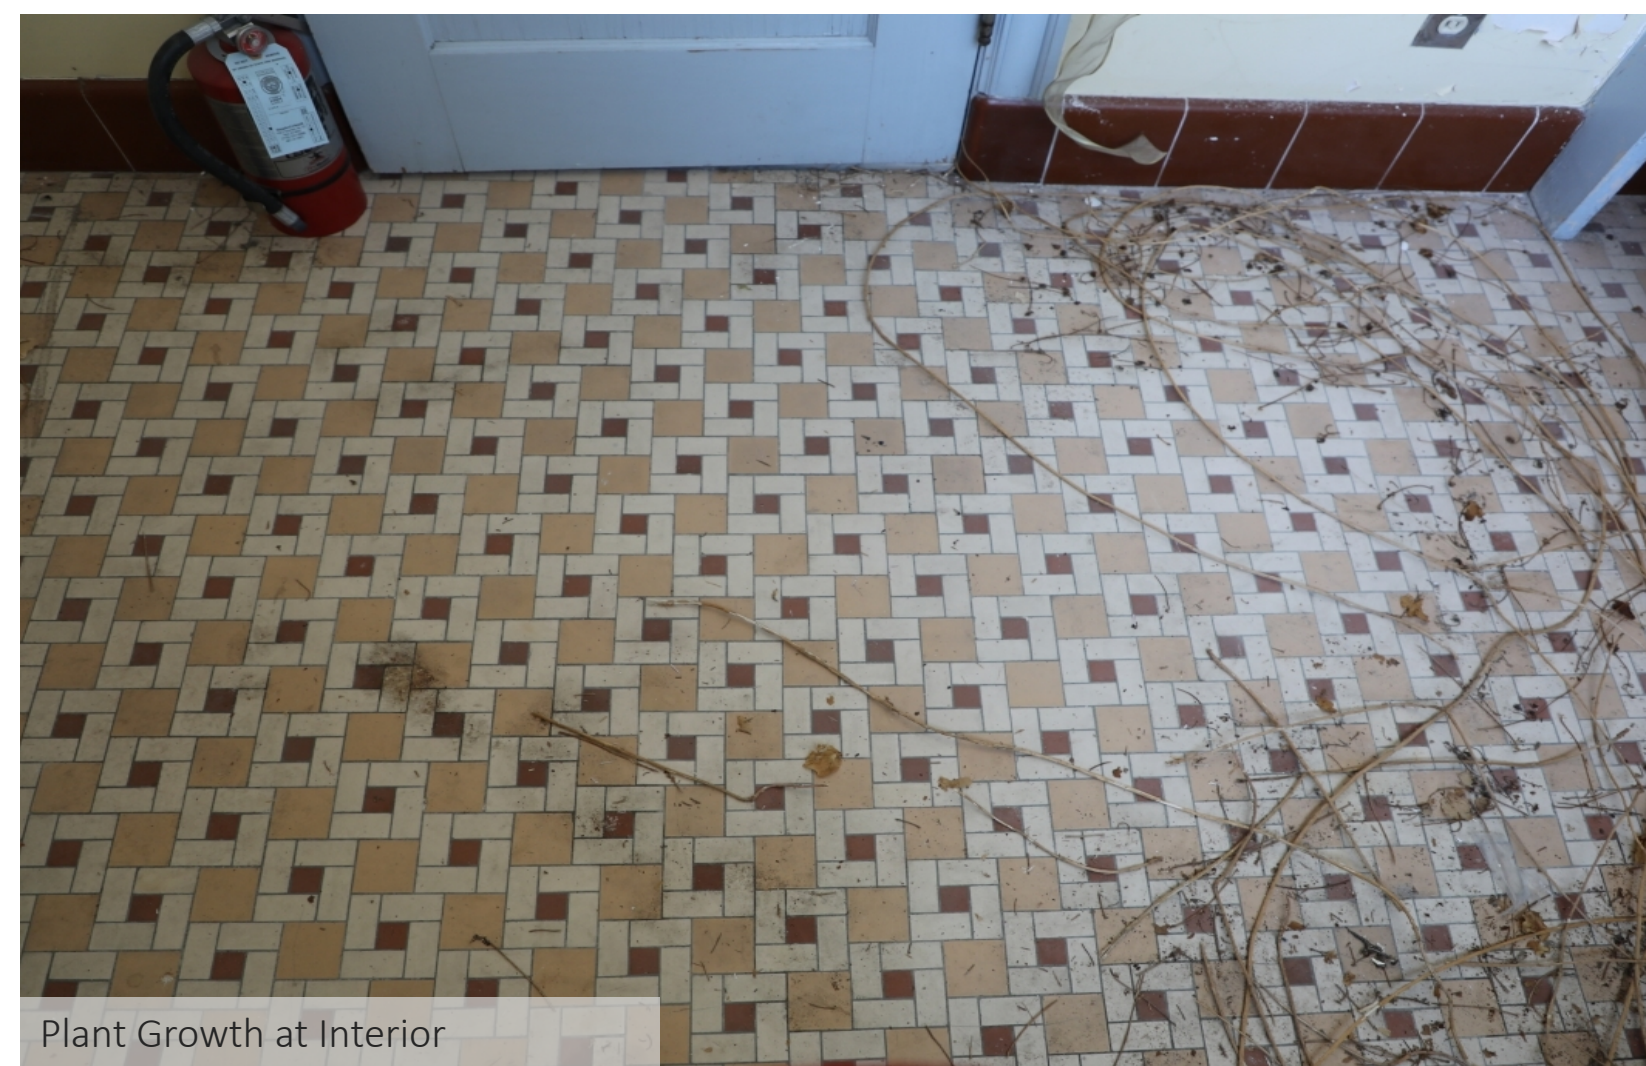
Plant Growth at Interior
