Odor Remediation Barrier - Details

5412 side Saddle Trail

Odor Remediation Project - Top Down View
5412 Side Saddle Trail

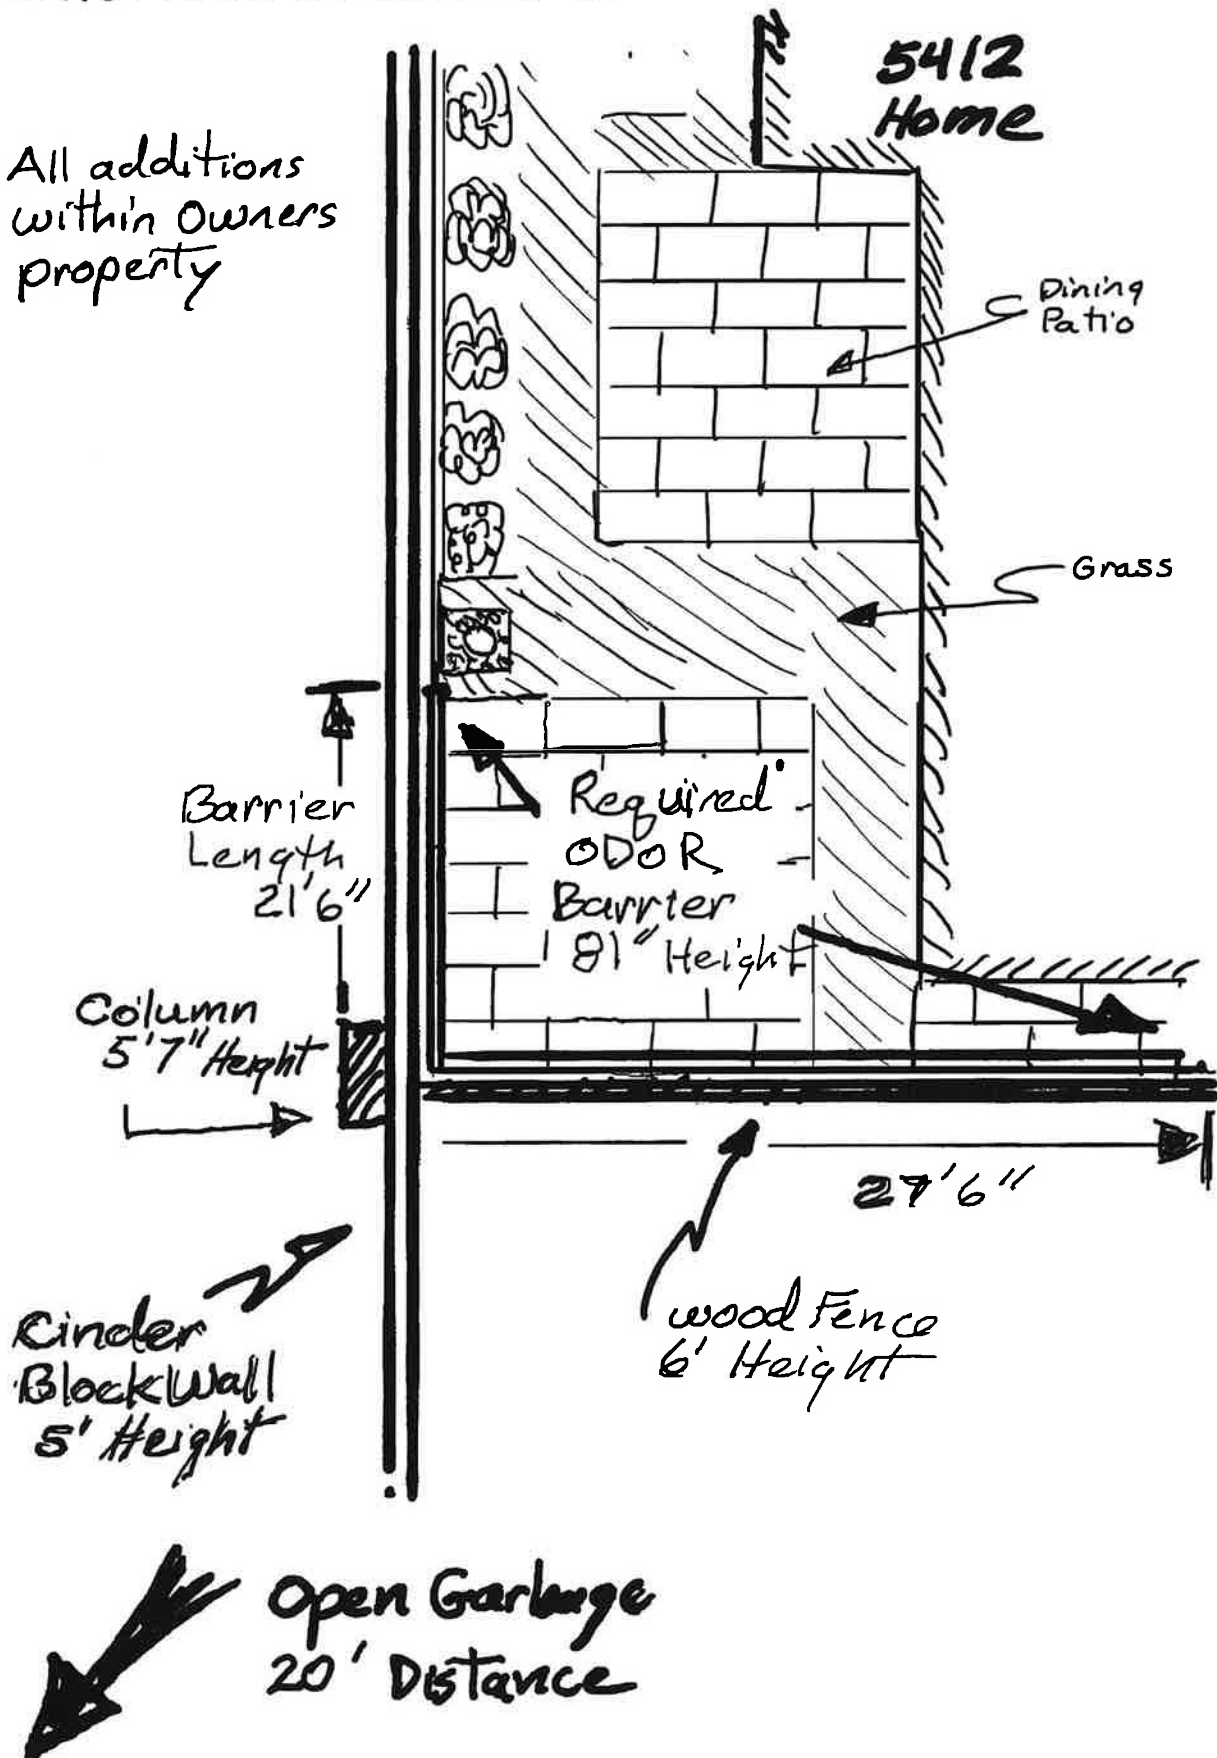
All additions
within Owners
property

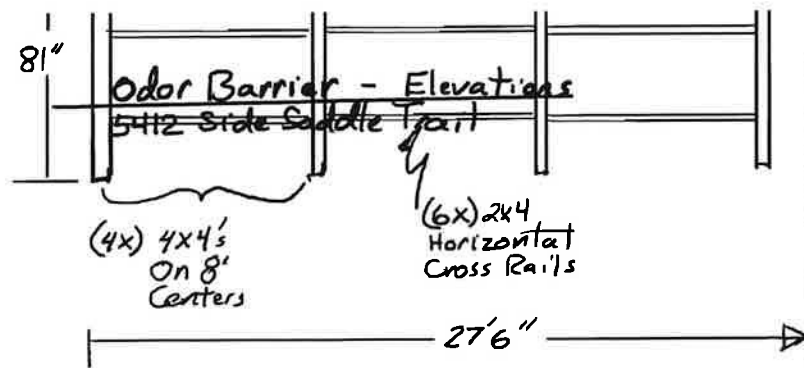
NOTE: Post Holes sunk 24" cemented in Place

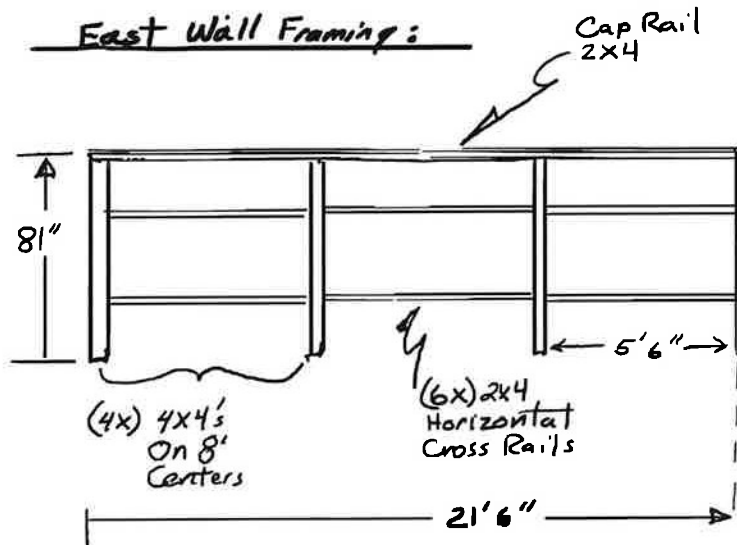
East Wall Framing:

NOTE: Post Holes sunk 24" cemented in Place
