HISTORIC STRUCTURE REPORT

Lear Theater

City of Reno | October 18, 2024

Lear Theater Structural Condition Assessment

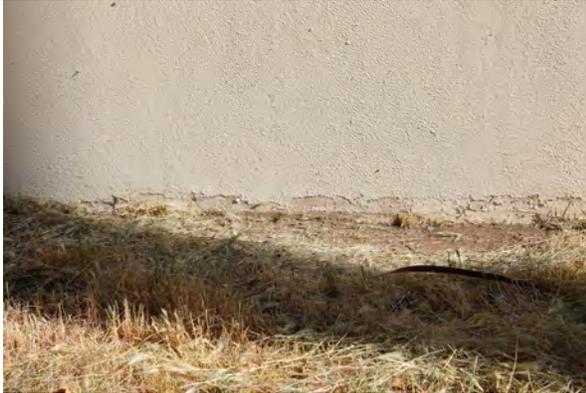
Figure 01: Deteriorated paint at the base of the exterior stucco walls along the south elevation

The exterior walls are in good overall condition, though minor cracking of the finish is visible along the length of the south elevation. The painted finish of the south Terrace wall shows minor paint loss, which has been coated over, resulting in a telegraphed appearance on the surface. Extensive ivy growth is present along the southern portion of the west elevation. Removal of ivy typically results in the loss of paint coatings.

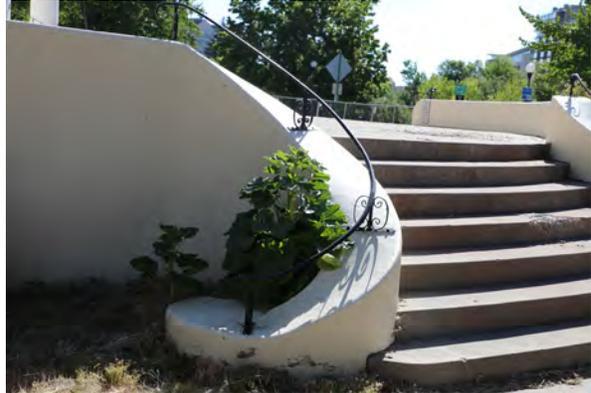
Figure 02: Non-compliant handrails at the southwest stair

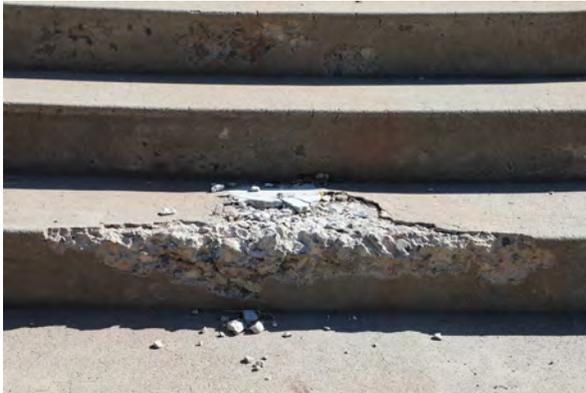
Figure 03: Significant deterioration of the concrete steps at the southwest stair

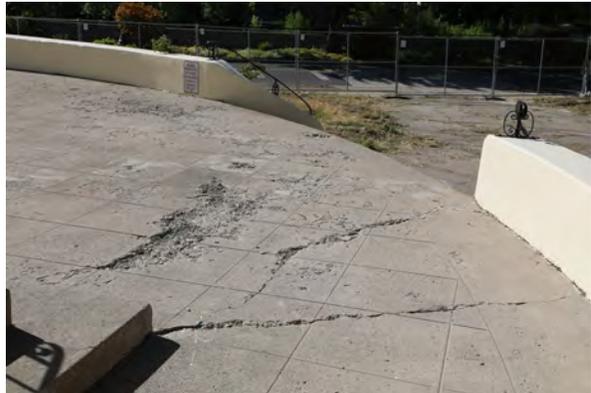
Figure 04: Significant spalling of the concrete of the south entrance Terrace

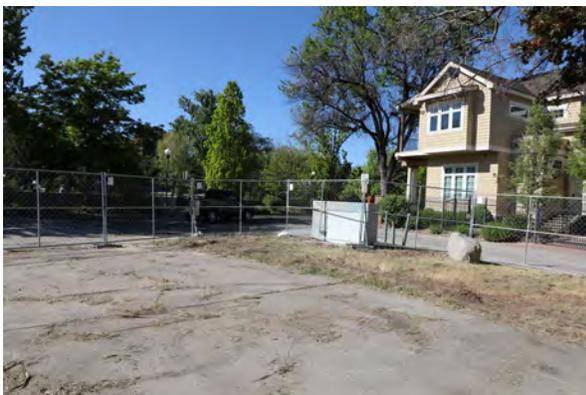
Figure 05: Extensive plant growth and spalling of the walk path at the south entry

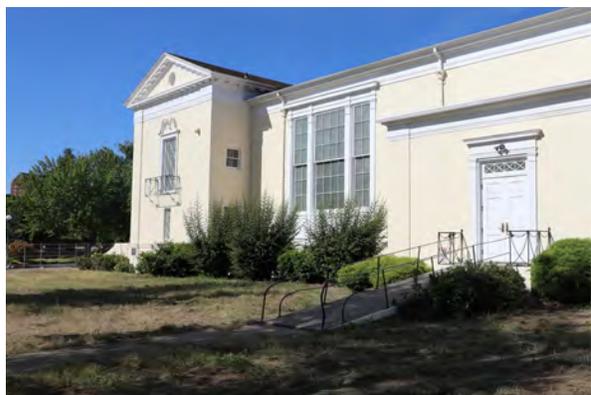
Figure 06: Non-compliant ramp and sidewalk overgrown with vegetation at the east entry

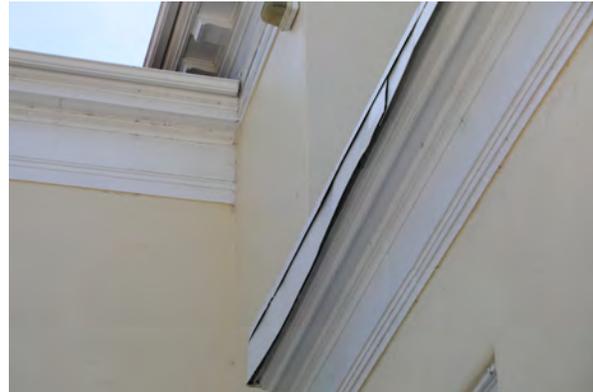
Figure 07: Unsecured sheet metal flashing at north wall of the west wing

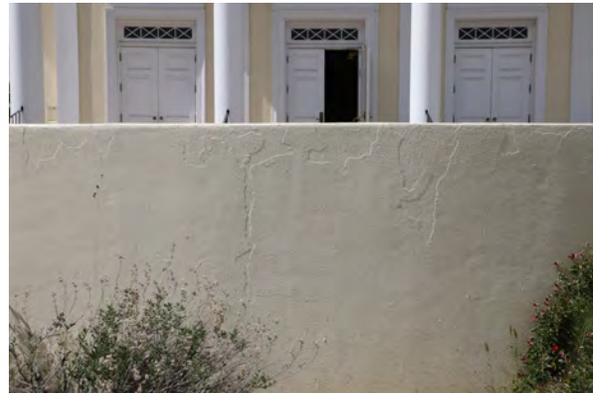
Figure 08: Paint loss telegraphing through new paint coating at south face of the south terrace

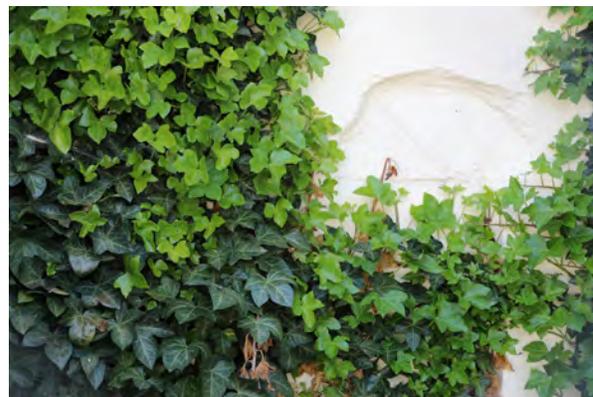
Figure 09: Extensive ivy growth at the west wall of the west wing

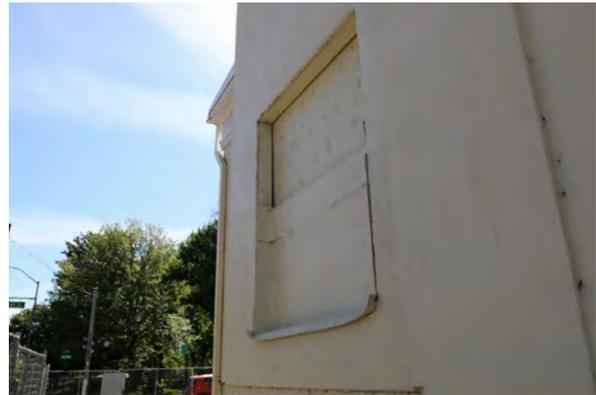
Figure 10: Boarded opening at the east end of the north façade

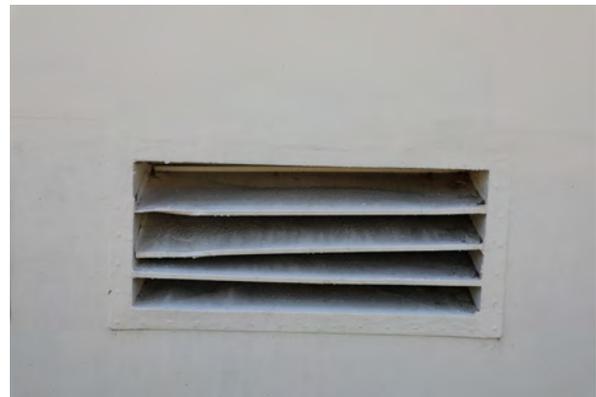
Figure 11: Damaged fins of the louver at the north elevation

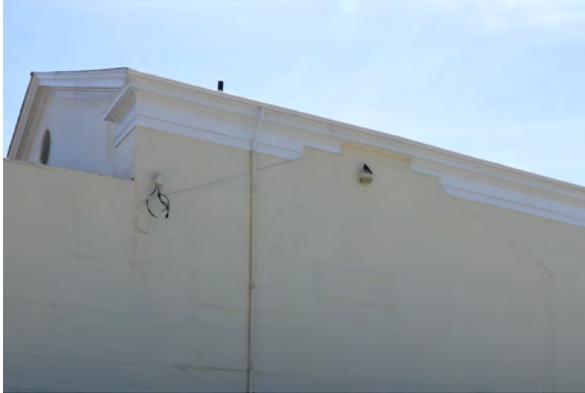
Figure 13: Temporary membrane at the west elevation

and sheathed, and concealed with a plastic membrane. As the membrane was intended for temporary installation, it has since detached from the substrate and is significantly bubbled.

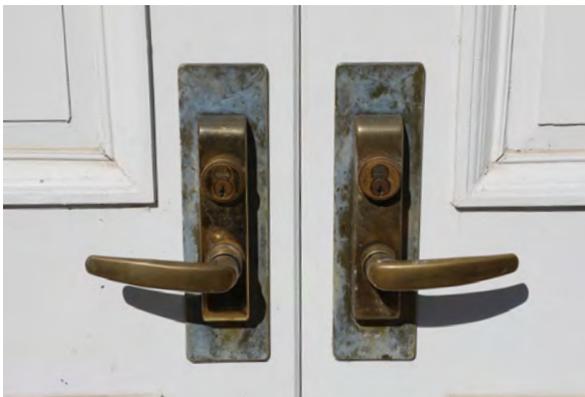
Figure 15: Tarnished hardware at east entry (Door 1-04)

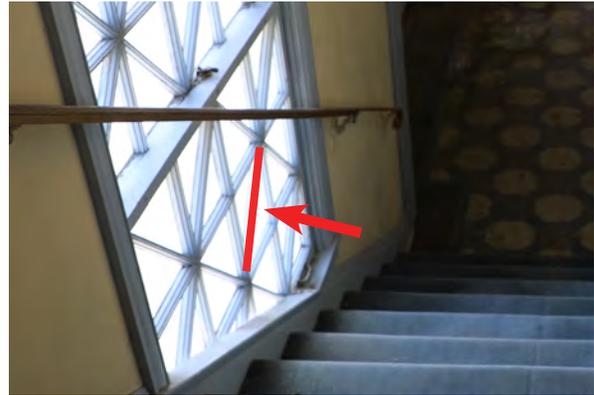
Figure 16: Missing interior muntin at Window 1-12

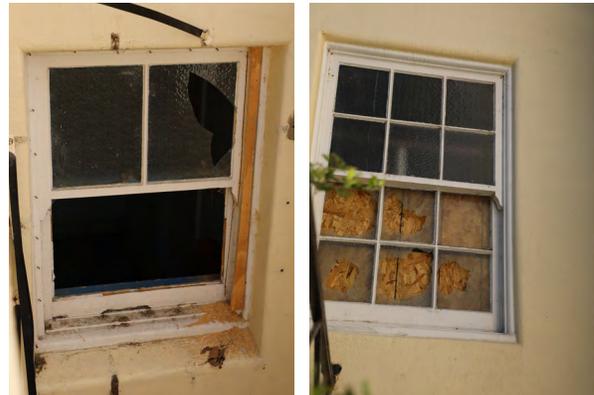
Figure 17: Damaged sash and broken or missing glazing at Windows 0-10 (left) and 1-10 (right)

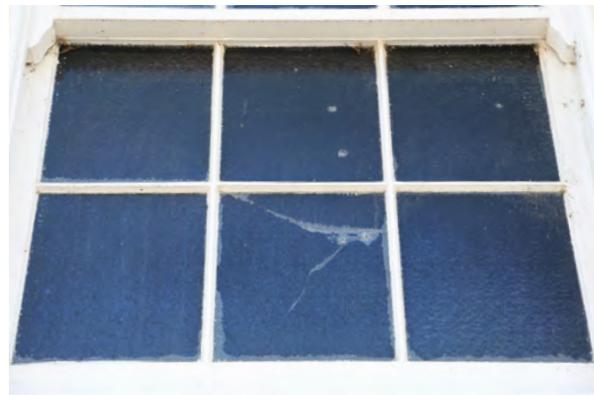
Figure 18: Damaged glazing at Window 1-01 on the north wall

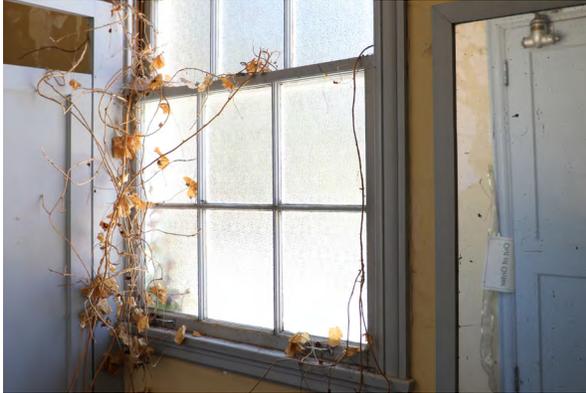
The window of the Women's Restroom (Room 112) is an original painted six-over-six double-hung wood window. The window remains intact, though ivy growth is present, with vines extending to the interior side and onto the surrounding walls. The window retains its original textured glass panes, which are in good condition. The window

Figure 19: Ivy growth at window 1-20 in the Women's Restroom (Room 112)

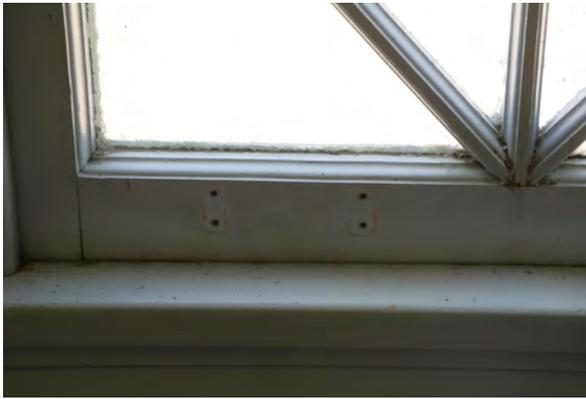
Figure 20: Missing hardware at bottom sash of Window 1-16 in the West Lobby (Room 115)

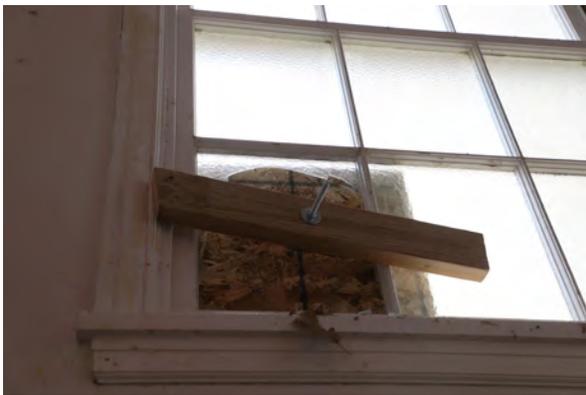
Figure 21: Broken glazing in bottom sash of Window 1-05 at the northern stairs (Room 008)

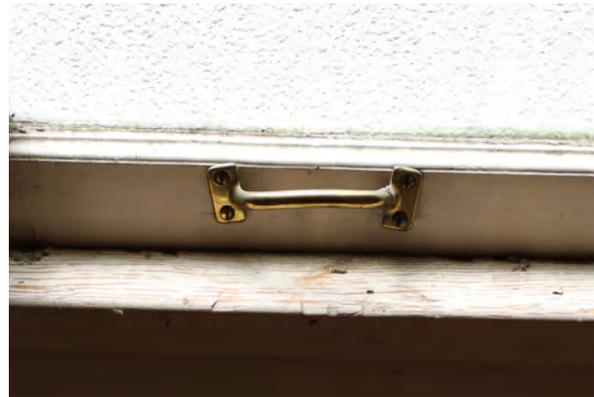
Figure 22: Damaged (bent) hardware at Window 2-04 in the Committee Room (Room 204)

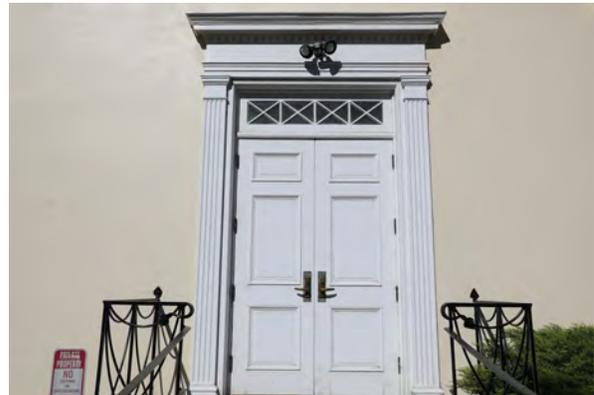
Figure 23: Exterior flood light at the East Entry

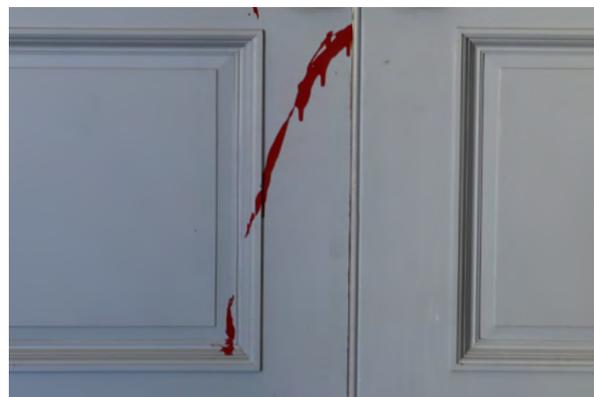
Figure 24: Red paint on Door 1-08 in the Foyer, Room 101

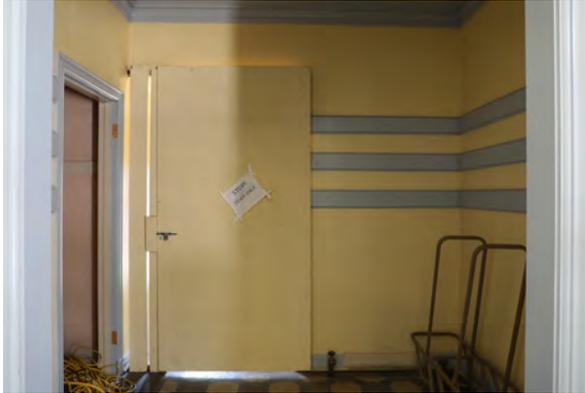
Figure 25: Makeshift plywood door in Lobby (Room 103) and missing door to Closet at the left

The door of the closet within the Lobby (Room 103) has been removed, but the original painted wood trim and opening remains intact and in good condition. It is likely that the door was a single, painted, paneled wood door, consistent in style with the extant doors at the first floor.

The opening between the Lobby (Room 103) and adjacent Stairs (Room 104) is concealed by a makeshift painted plywood door installed to secure access to the basement below. The original painted wood trim around the opening has been removed, leaving visible damage to the painted finish where the trim was previously attached.

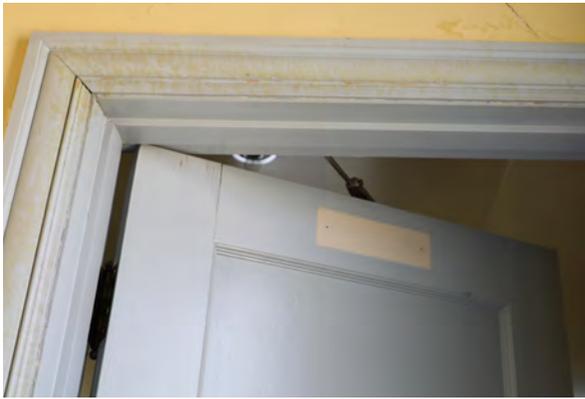
Figure 26: Missing paint at the top rail of the Men's Restroom (Room 105) door and yellow residue visible at the trim

A single, two-panel painted wood door is located at the entry to the Men's Restroom (Room 105). The door features a metal closer that ensures it closes automatically. The door hardware includes a simple, round knob with a stainless steel finish on the interior side and a brass finish on the exterior. Signs of wear are visible along the door panel and frame, with paint loss present at the top rail of the exterior side, from the removal of previously installed signage. There are open seams along the frame and door components, along with minor paint loss and scuffs across the painted surface. The trim on the exterior side of the door has a yellow residue on its surface. The original marble threshold remains in place, but it creates an obstacle for universal access to the restroom, as it stands one inch above the existing floor of the landing. This could be easily remedied by installing a new floor finish over the unfinished floor of the Stairs (Room 105), which would reduce the floor height difference between these spaces. Additionally, the clear opening dimension for the door measures 27 inches wide, which does not meet ADA requirements for accessibility.

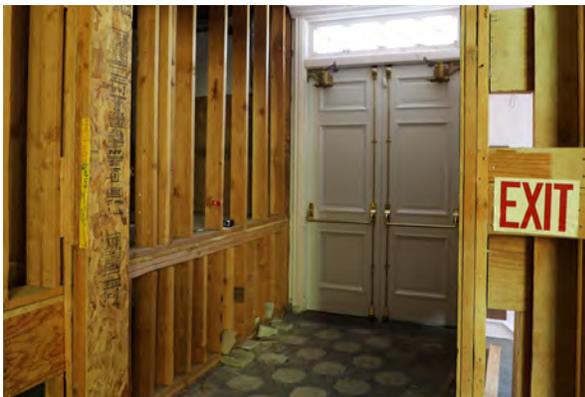
Figure 27: Unfinished construction at the East Entry (Room 109) showing rough opening and wall framing

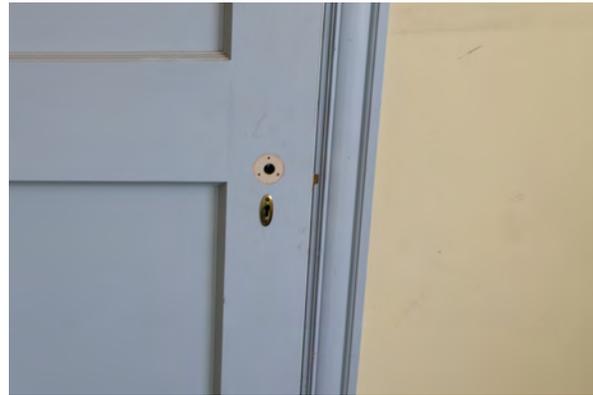
Figure 28: Missing hardware at Door 1-05

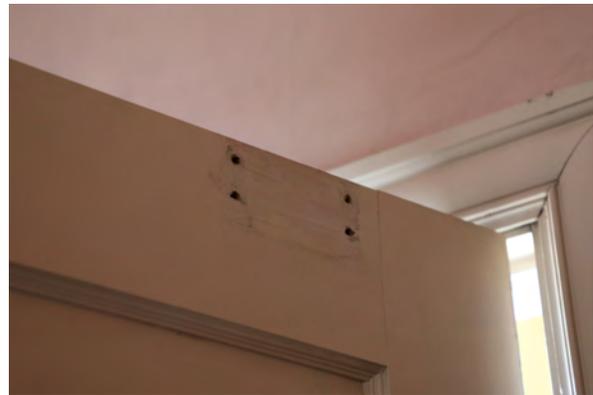
A single, two-panel painted wood door is located at the entry to the Women's Restroom (Room 202). The door hardware includes a simple, round knob with a stainless steel finish on the interior side and a brass finish on the exterior. The door closer is missing, leaving the door without an automatic closing mechanism. The door itself is in good condition, with minimal wear. The original marble threshold remains in place; however, it presents a barrier to universal access due to its height above the finished floor. Additionally, the clear opening dimension for the door measures 27 inches wide, which does not meet ADA requirements for accessibility.

Figure 29: Missing door closer at Women's Restroom, Door 2-01

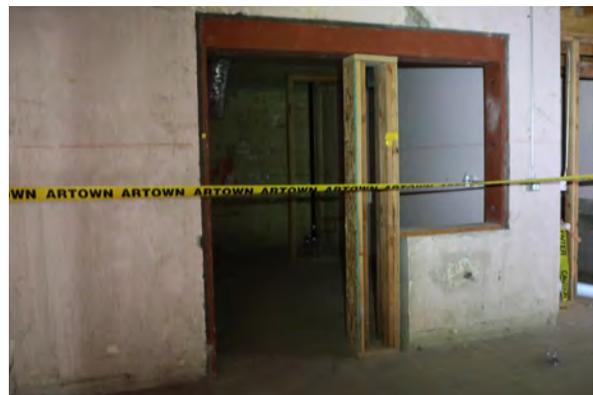
The only extant features at the original openings in the basement of the Theater are located at the Lobby (Room 003), the Registry (Room 002), and the Dressing Room (Room 004). At these locations, the painted wood trim remains, though the doors have been removed. The

Figure 30: Unfinished openings in basement

remainder of the original openings have been significantly modified and are in a state of partial construction.

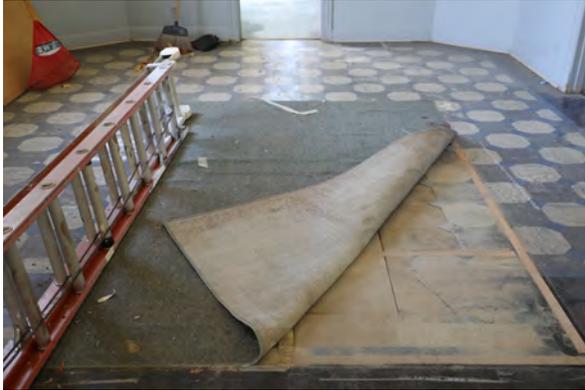
Figure 31: Fire damaged and missing vinyl tile under a temporary carpet section in the west Lobby (Room 115)

The vinyl tile is in fair overall condition, with visible paint spills and water damage in multiple locations. Deep scrapes are present in the tile finish on the east side of the Foyer. Significant soiling is evident around the south entry doors, along with some areas of tile uplift. Open seams were noted in various locations. Large sections of tile are missing in the closet of the Lobby (Room 103) and in the west Lobby (Room 115), where a previous fire resulted in significant damage to the tiles.

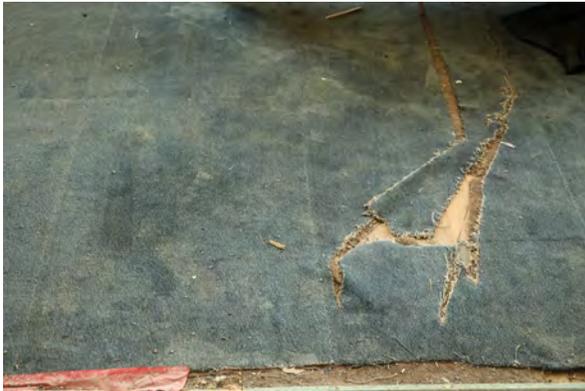
Figure 32: Damaged and worn broadloom carpet in Auditorium (Room 107)

The broadloom carpet is generally in poor condition throughout. The carpeting in the Auditorium is significantly worn and threadbare, exposing the subfloor below. The carpeting in the remaining locations is similarly worn, with material deterioration, including several areas with paint stains and significant dirt accumulation.

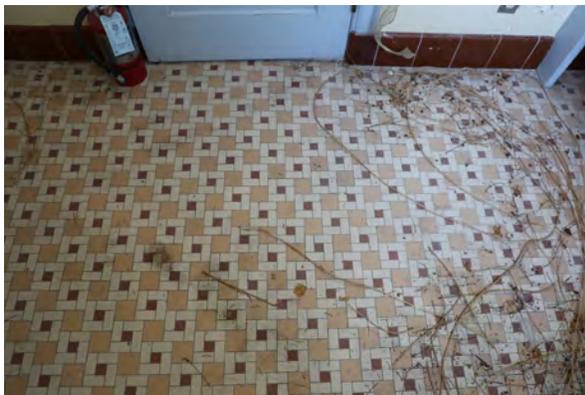
Figure 33: Dirt accumulation at original tile in Women's Restroom (Room 112)

The flooring in the restrooms consist of mosaic patterned tile with small rectangular and square tiles in beige, white, and reddish-brown tones. The tiles are arranged in a repeating geometric pattern. The tile is generally in fair condition, though there is visible dirt accumulation and debris present. Some areas show signs of wear, but the tile pattern remains intact. The grout lines, while slightly discolored, appear to be intact, and there are no significant signs of cracking or material loss noted in the visible sections of the floor.

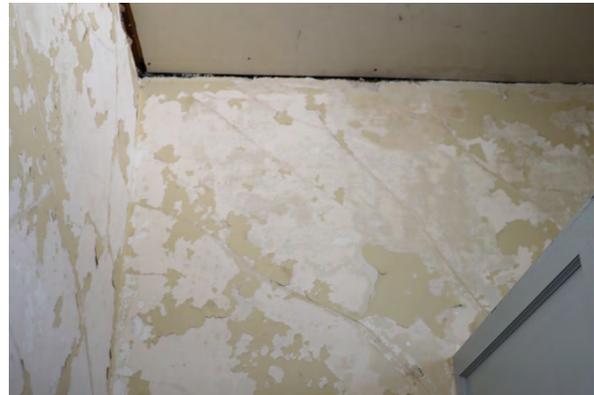
Throughout most of the building, the plaster finish is in fair to poor condition. There is extensive cracking and visible signs of smoke damage or general staining throughout. Although the painted wood trim and wainscot are generally in good condition where installed, some portions of the extant wainscot are unpainted where the original radiators were removed. The painted plaster finish in the Women's Restroom (Room 112) is significantly damaged, likely due to the removal of ivy growth, which caused extensive damage

Figure 35: Severely damaged paint finish and plaster, possibly caused by ivy removal in the west Women's Restroom (Room 112)

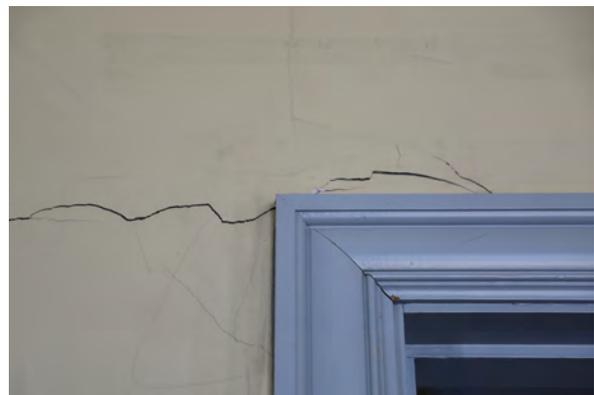
Figure 36: Significant cracking of plaster at cased opening on the north wall of west Lobby (Room 115)

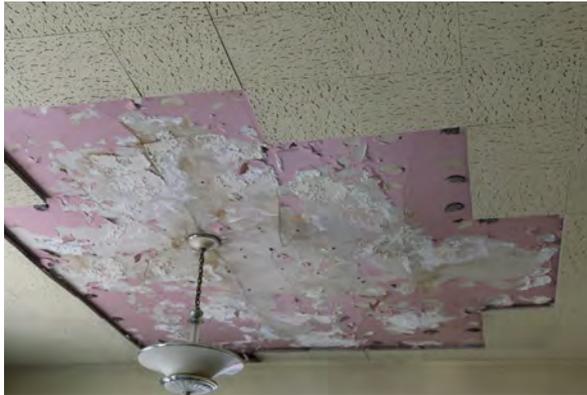
Figure 37: Missing acoustic tile and damaged historic finish at ceiling of the Literature Room (Room 114)

The ceilings throughout the building are generally in fair to poor condition. Three ceiling types are present: adhered acoustic tile applied over the original plaster finish in the Literature Room and Lobby (Room 115); unfinished drywall in the Women's Restroom (Room 112); and original plaster and lath.

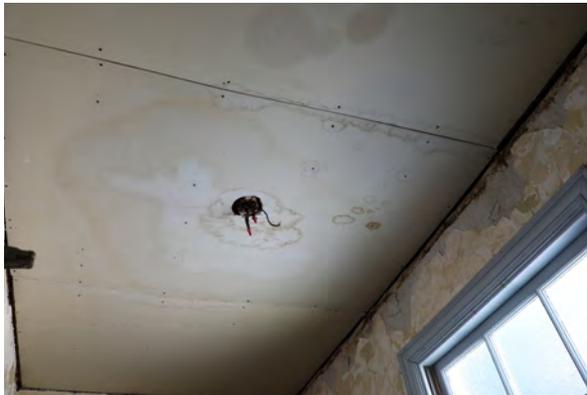
Figure 38: Moisture damage, unfinished drywall, and removed light fixture at ceiling of west Women's Restroom (Room 112)

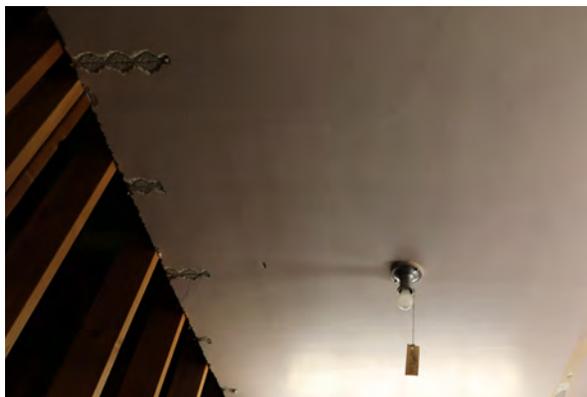
Figure 39: Loss of finish material and plaster at ceiling of east Entry (Room 109)

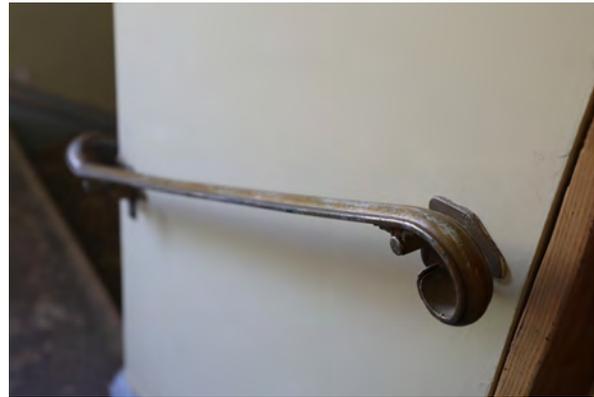
Figure 40: Stair handrails lack ADA compliant extensions, and are not at the proper height

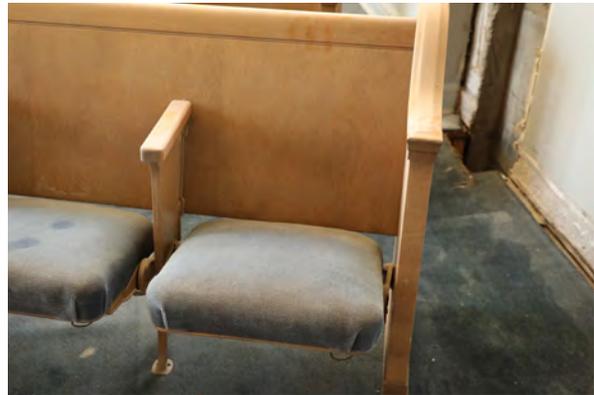
Figure 41: Accumulation of dust and dirt on theater seating upholstery in the Auditorium (Room 107)

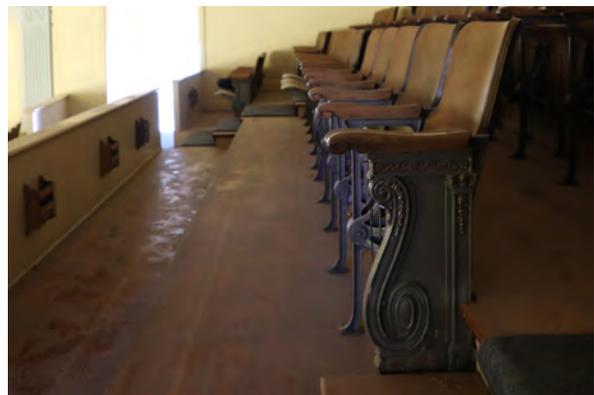
Figure 42: Original theater seating showing slight wear and tear and dust accumulation at Balcony (Room 203)

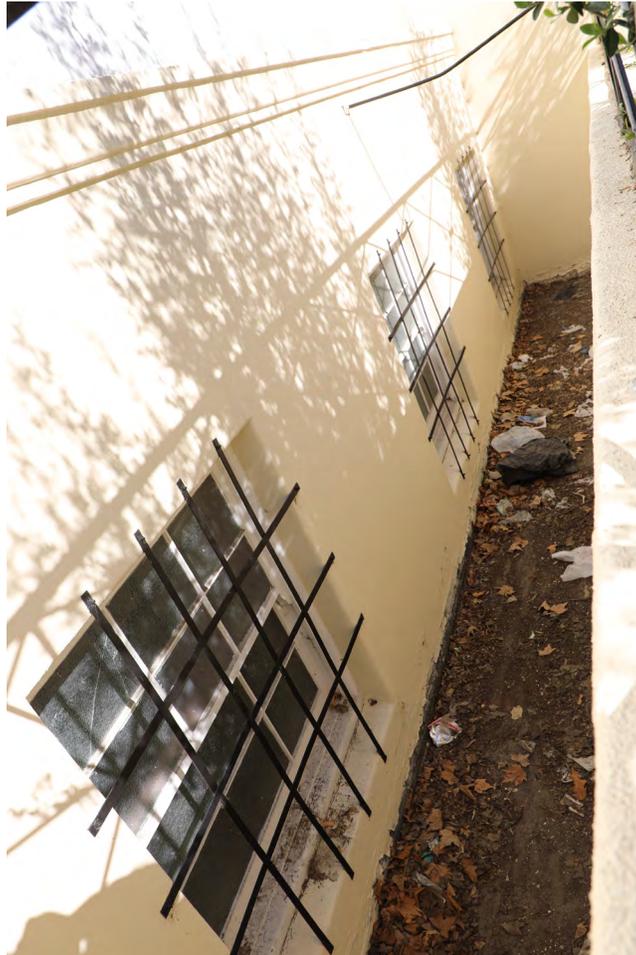
Figure 11 - View into areaway at basement windows along the east facade, view north (ARG, 2024)

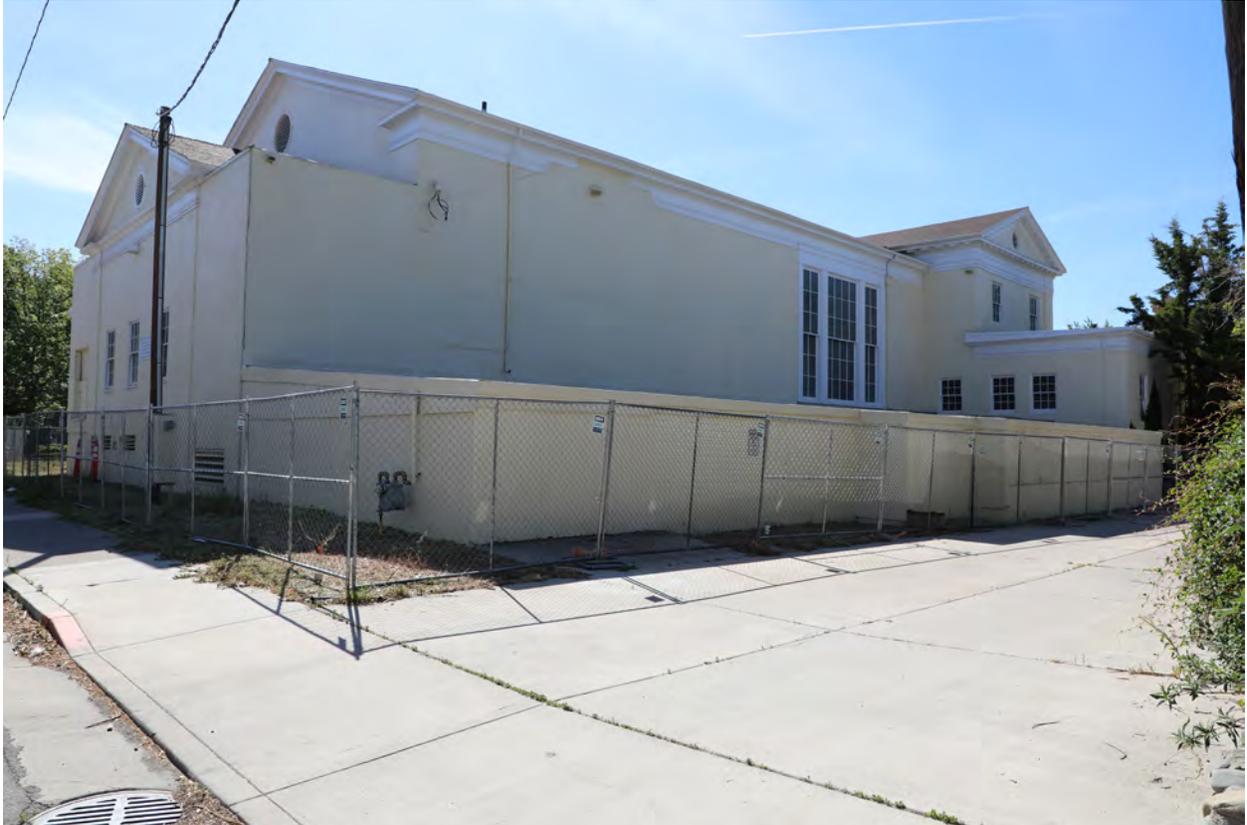
Figure 13 - West facade showing incomplete 2002 addition, view southeast (ARG, 2024)

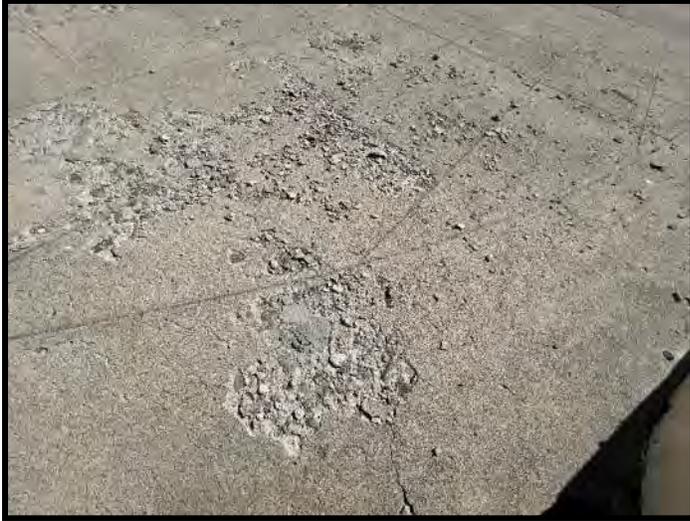
The exterior slab-on-grade at the south theater entrance (highlighted in **Figure 23**) is significantly spalling. These are likely caused by the changing weather conditions, corresponding freeze-thaw cycles, and chloride content within the slab. **Figure 24** below shows one of the spalling regions observed on site.

Figure 24 View of spalling slab-on-grade at the south entrance to the theater.

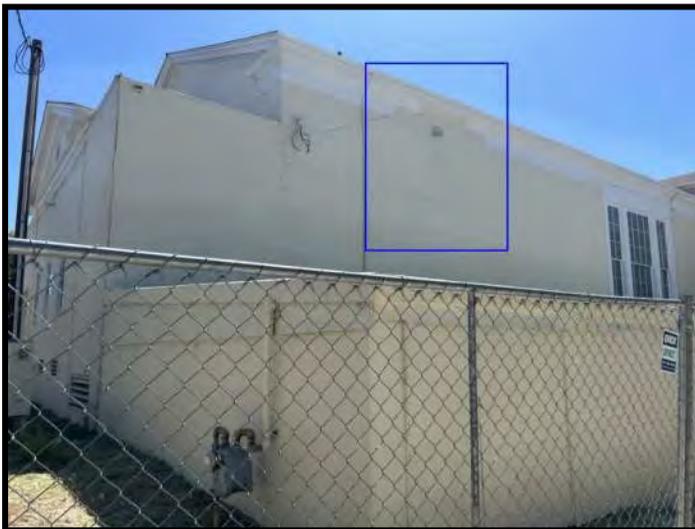
In addition to the temporary floor framing, it appears some of the west exterior wall was temporarily enclosed in a plastic membrane. While on-site, Silman noted this membrane is bubbling as shown in **Figure 30**.

Figure 30 View of bubbling plastic membrane at the west exterior wall.

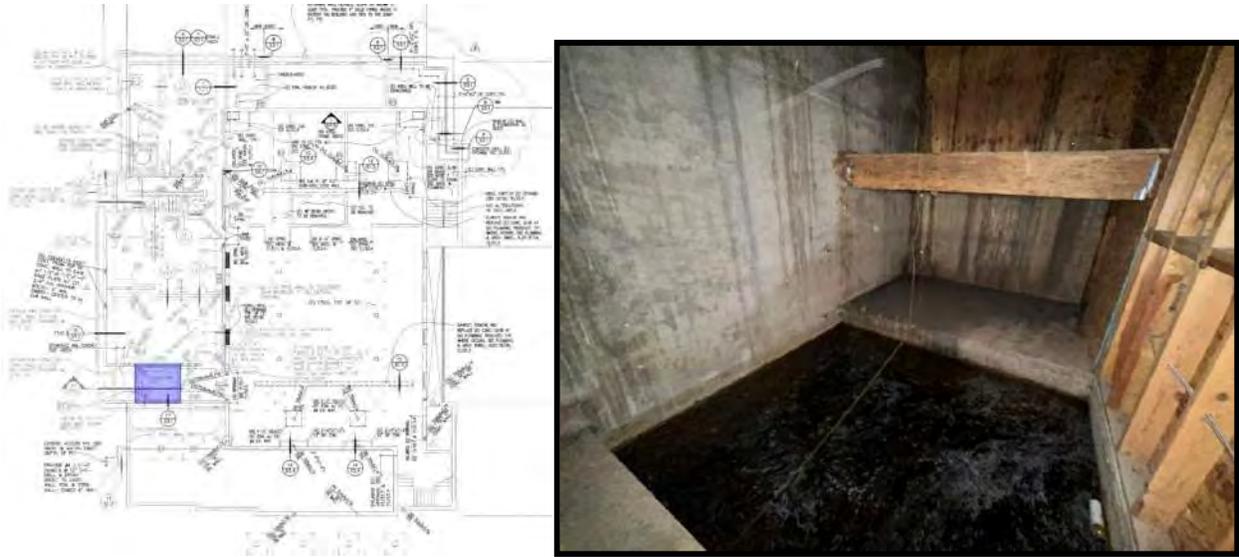
As shown in **Figure 31** below, the southernmost elevator pit is flooded.

Figure 31 Basement plan view highlighting the location of the flooded elevator pit (left). View of the flooded elevator pit (right).

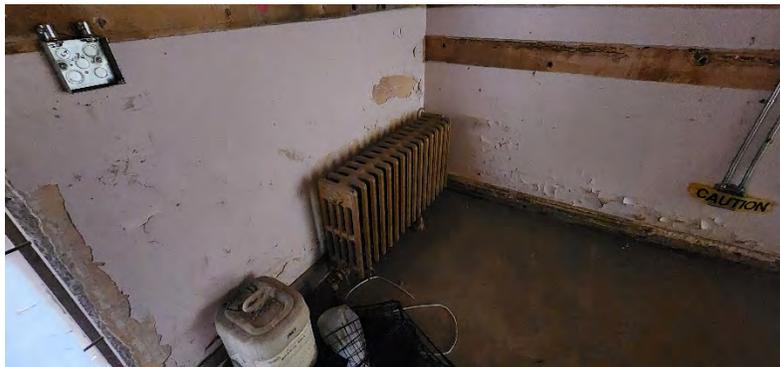
Old steam radiator:

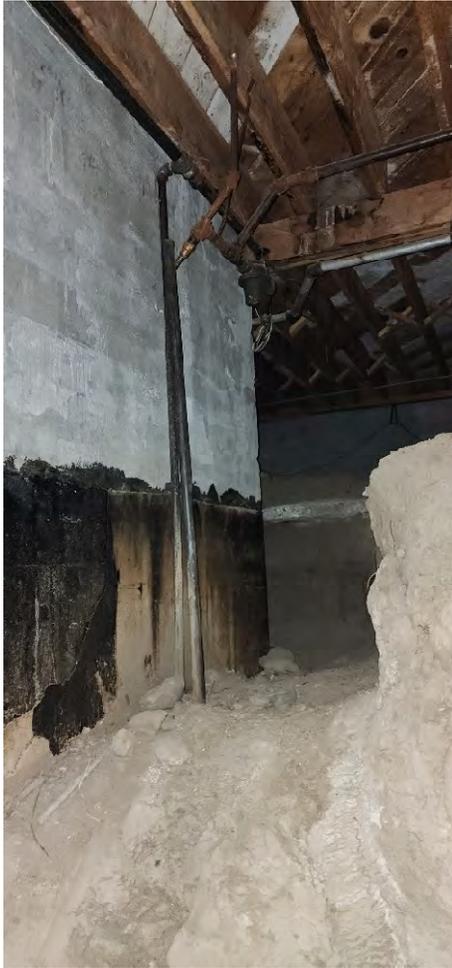
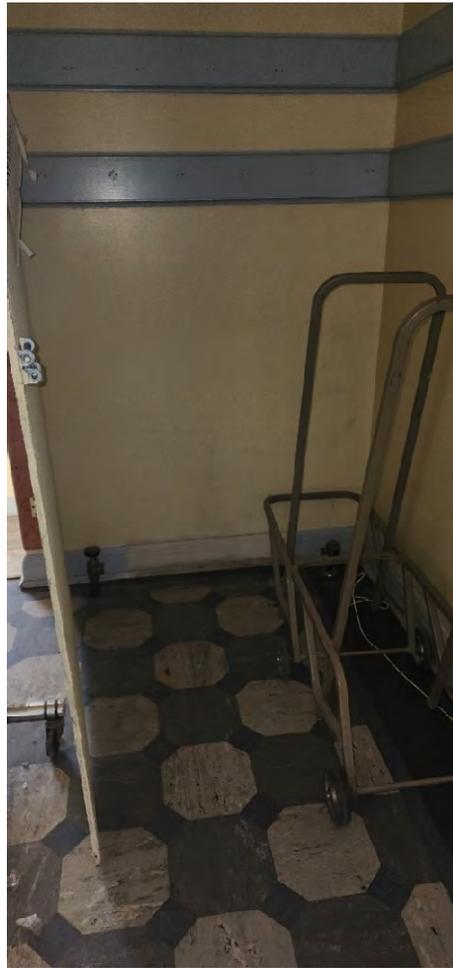
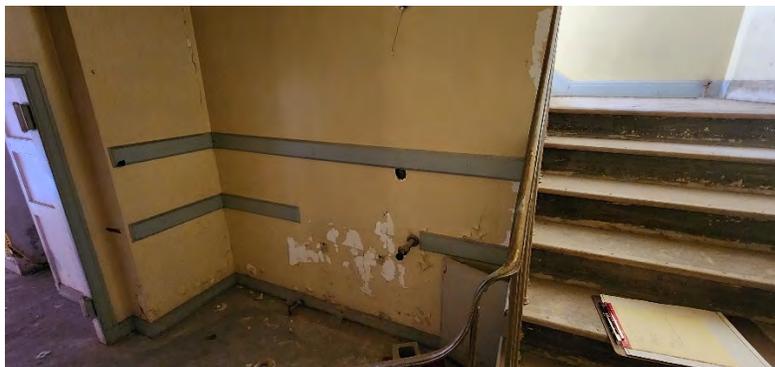
Abandoned steam piping:

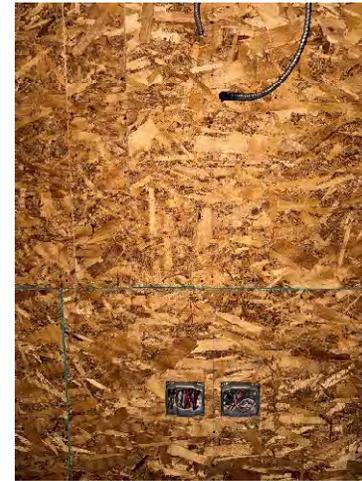
Photo 6

Infrastructure for new circuits was added in the recent past, based on a project prior to 2002.
